## 1-2 Accumulator Spring Set

**36946-05K**

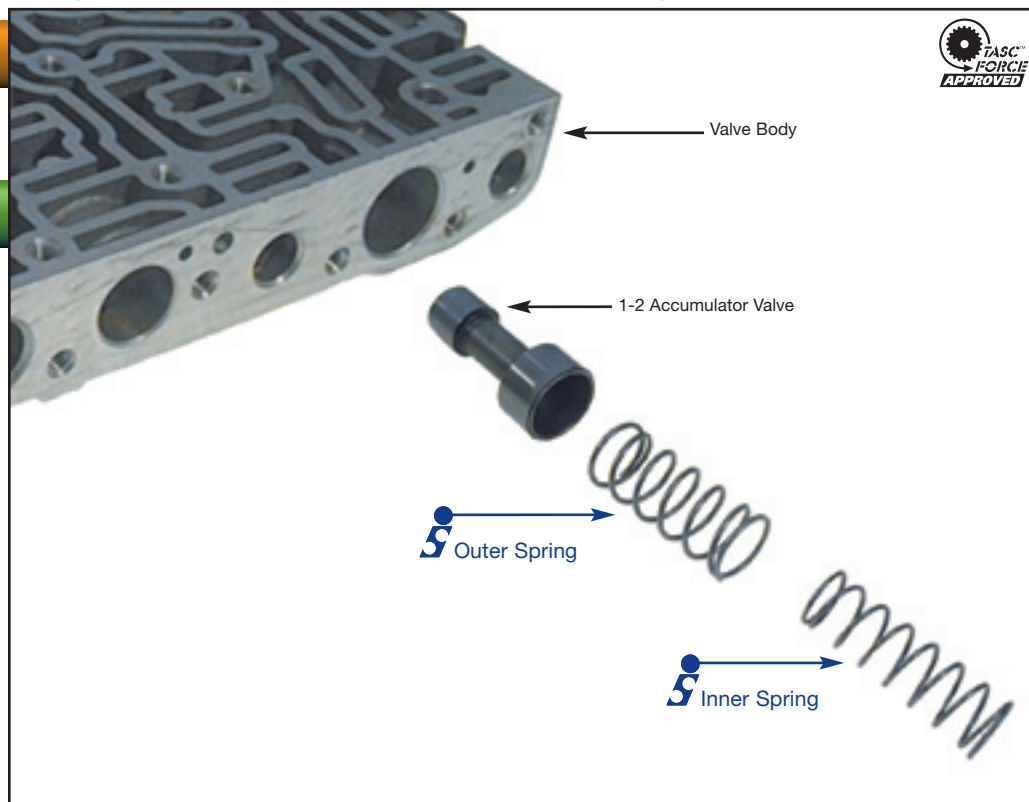
## Harsh 1-2 shift

• Long slide 1-2 shift • Burned clutch band • Broken springs

1-2 accumulator valve springs weaken, collapse and break due to high stress levels.

This replacement spring set for the C6 1-2 accumulator can withstand higher stresses and has greater fatigue resistance.
