## Oversized Pressure Regulator Valve

### 36946-10K

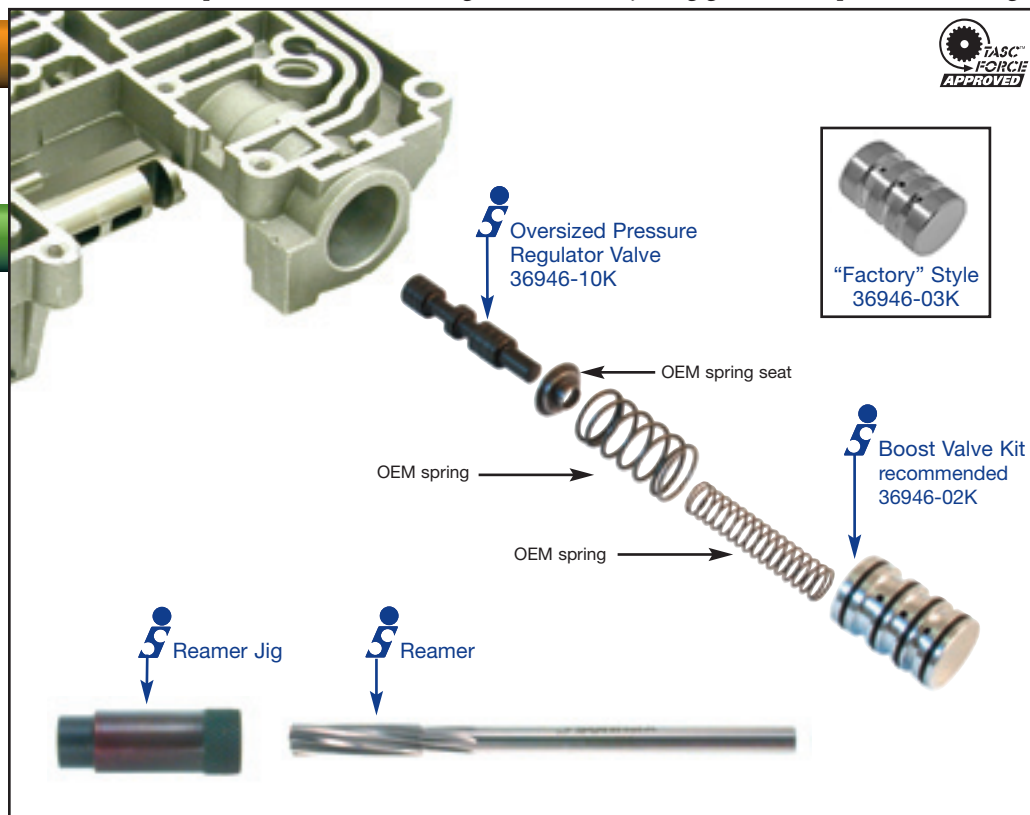
Continuous oscillation of the steel valve wears the cast aluminum bore, allowing valuable oil to leak.

Bore wear at the inside spool causes imbalance or a buzz condition along with high line pressure at operating temperatures. High line pressure causes harsh engagements and reduced converter fill. The valve bore also wears near the second spool. This wear reduces line pressure and causes delayed engagement or soft/flare upshift concerns. Sonnax now offers an oversized pressure regulator valve **36946-10K** for the C6 transmission. Reaming the bore and installing a new closely tolerated valve corrects various conditions.

This oversized valve permits the valve body to be restored to OEM specifications.
