4R100, E40D ('96 & UP)

PART NUMBER 36947-06K

Low/Reverse Modulator Valve Plunger & Sleeve

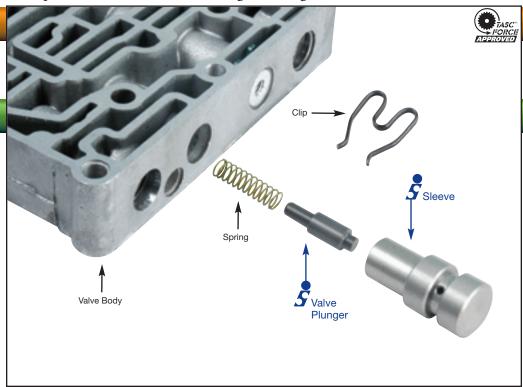
Wear at the low/reverse modulator valve plunger sleeve bore due to continuous oscillation.

Burned low/reverse clutch

• Low pressure at L/R clutch • Loss of engine braking

The replacement Sonnax assembly restores proper clearances for hydraulic sealing with a tightly toleranced and wear-resistant plunger valve and sleeve.
