### Oversized Manual Valve

#### 36947-13K

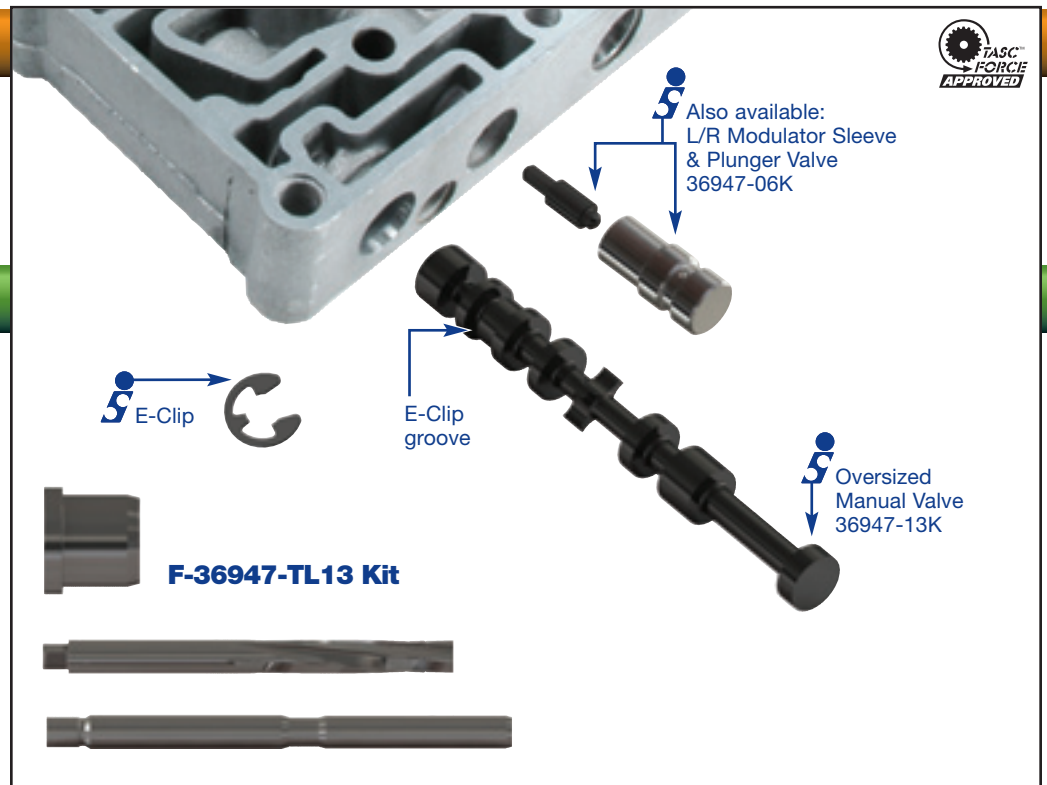
Continued movement of the steel valve within the aluminum bore. Lack of optimal valve and linkage stability creates wear and scoring of the manual valve bore, reducing line pressure in reverse and manual low positions.

The Sonnax oversized hard-coat anodized aluminum valve allows the valve bore to be refurbished, and has an increased stem diameter at the detent lever and an additional spool for increased stability.
