Improved Shift Accumulator Spring Kit

36948-18K

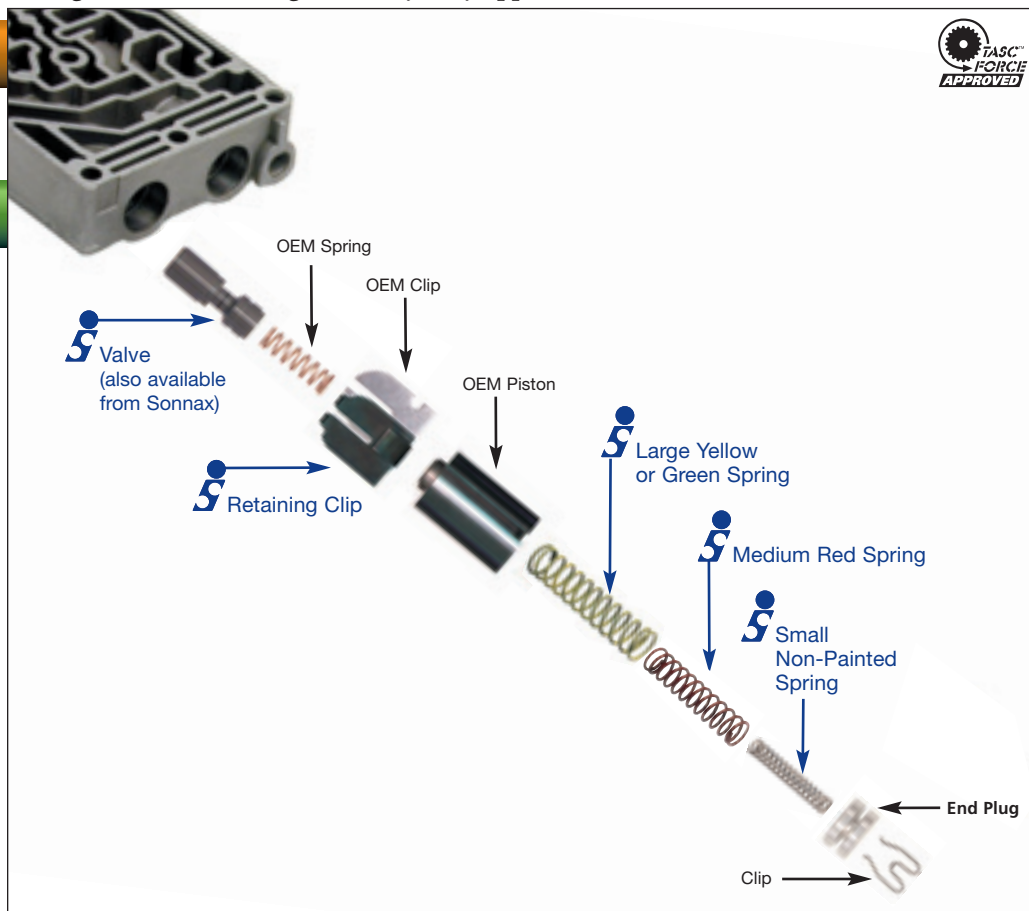
The OEM E4OD and 4R100 accumulator springs can break, weaken or collapse, causing long, soft shifts, particularly in towing and heavy-duty applications.

Replace accumulator springs with Sonnax improved shift feel accumulator spring kit.
