## Boost Valve & Sleeve Kits

### Sonnax Part Summary

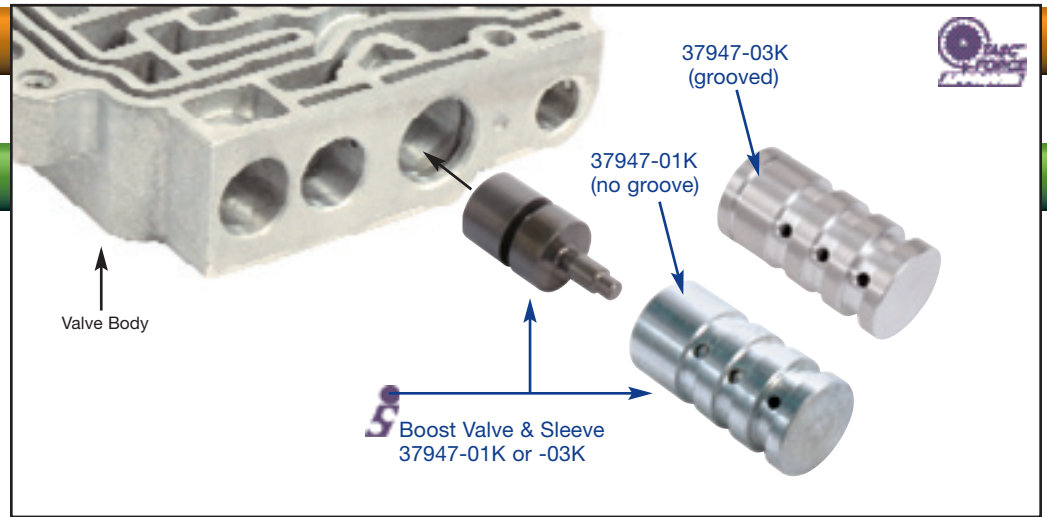
Soft shifts, delayed reverse

- Low line pressure • Poor modulator control

A worn boost valve or boost valve sleeve.

**Note:** OEM sleeves may come in either a 3- or 2-circuit design. Boost valve kits **37947-01K** and **-03K** may be used to replace either version.

Restore proper line pressure control with closely toleranced boost assemblies, made from wear-resistant materials.
