Boost Valve & Sleeve Kits

Sonnax Part Summary

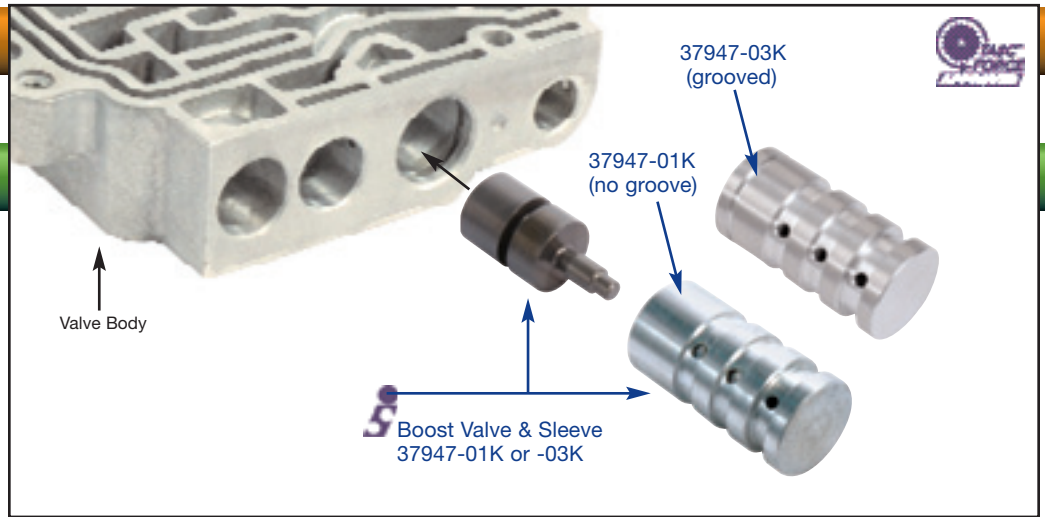
Note: OEM sleeves may come in either a 3- or 2-circuit design. Boost valve kits **37947-01K** and **-03K** may be used to replace either version.
