Pressure Regulator Sleeve Kit

37947-05K

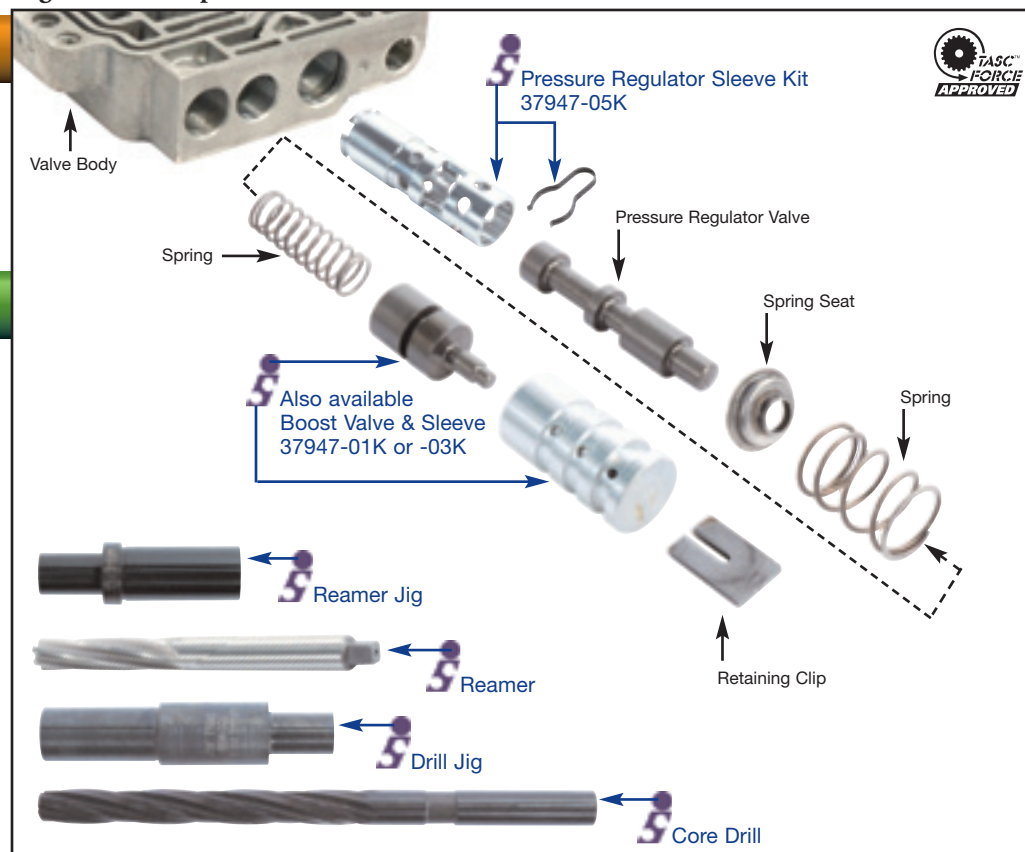
Wear at the inboard end of the PR valve reduces force, which affects converter feed and engagements, also creating higher line pressure. Wear at the mid-outer end reduces line pressure as it leaks to sump.

Delayed engagement due to poor converter fill

High or low line pressure • Low cooler flow at idle, overheat conditions

Constant oscillation of the pressure regulator valve can cause excessive wear at the balance line end of the bore, allowing balance line pressure to exhaust and preventing the pressure regulator valve from stroking to the lower line pressure position. Severe wear prevents line from entering the converter apply circuit, which will also restrict valuable cooler flow. Sonnax offers a highly wear resistant aluminum sleeve, 37947-05K, that mates with the OEM anodized aluminum valve. Use of this sleeve allows the valve bore to be oversized, and the hydraulic integrity of the bore to be restored.

The Sonnax kits contain a highly wear resistant aluminum sleeve to fit with the OEM anodized aluminum valve, providing additional support and proper line pressure control.
