# 4R44E/55E, 5R44E/55E

PART NUMBER 37947-13K

## **End Plug Kit**

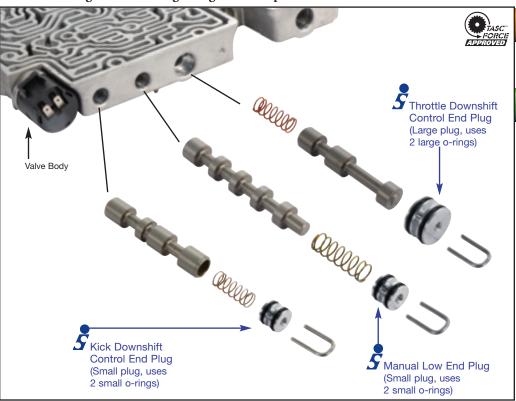
Wear of bore end plugs allowing solenoid feed oil to exhaust.

## Loss of 3rd or 4th gear, hot

• Erratic shifting • Shift timing change with temperature • Gear ratio and solenoid codes

The end plugs at the kick downshift control, manual low, and throttle downshift control valves become loose. This allows solenoid feed oil to exhaust and drop below 40-45 psi, which prevents the shift valves from stroking fully. The Sonnax kit **37947-13K** contains o-ringed end plugs for these three locations, which positively seal the circuit to prevent oil loss.

The Sonnax kit contains o-ringed end plugs to positively seal the bores.
