TCC Regulator Valve Spring Kit

37947-46K

Sonnax Part Summary

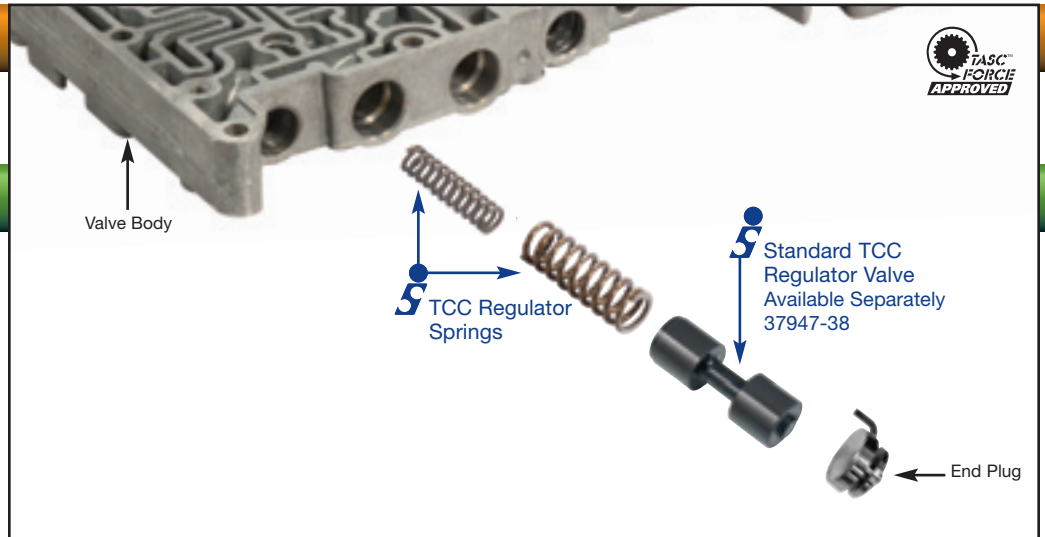
Low TCC apply pressure

TCC slip code, PO 741 • Low spring rate on 2.3L TCC regulator valve • Loss of valve body core

Incorrect spring rate for the TCC regulator valve.

The 2.3L TCC regulator valve has a lower spring rate and lower apply pressure than the 4.0L. If the incorrect core is installed or the springs have been damaged, the TCC apply pressure is reduced and slippage occurs. The springs in the Sonnax kit **37947-46K** have been designed to match the 4.0L calibration. The kit can be used to replace weak, broken or lost springs in 4.0L applications or to convert a 2.3L valve body core for use in a 4.0L application.

Recalibrate TCC apply to 4.0L rate.

Note: Not recommended for usage in 2.3L applications as firmer apply will result.
