Main Pressure Regulator & Boost Assembly

39741-01K

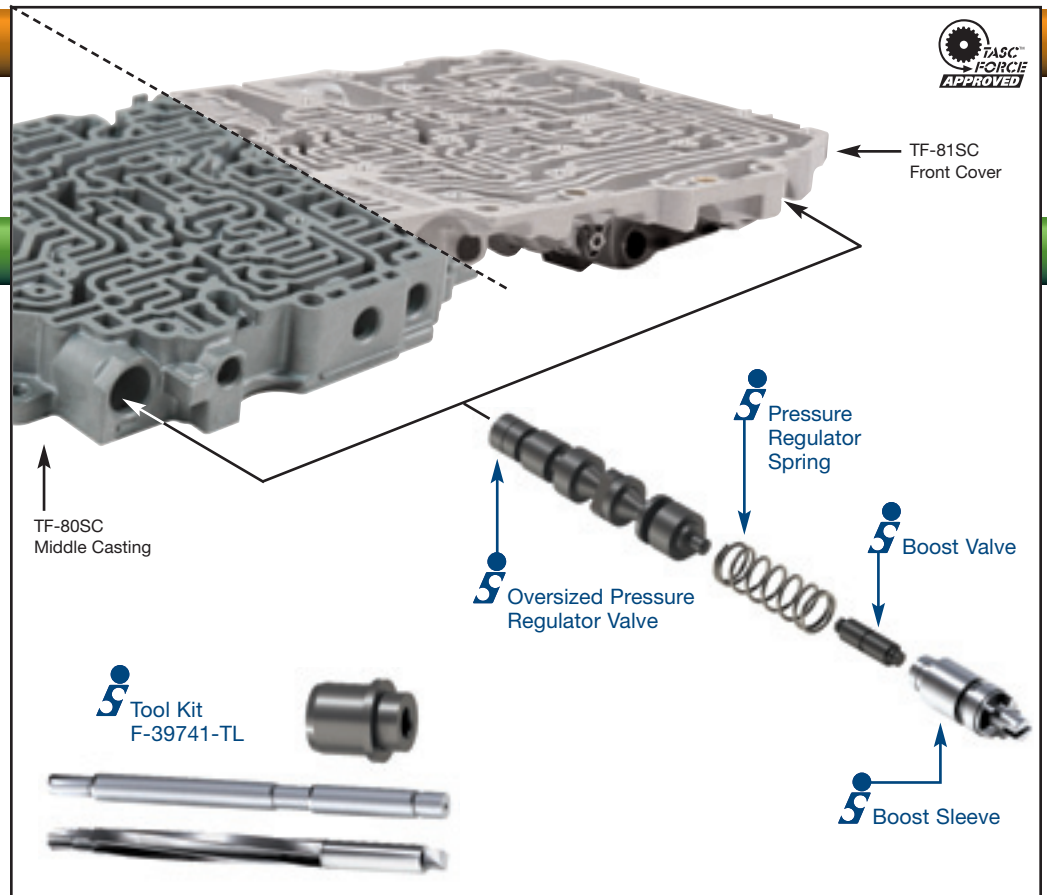
Excess pressure in reverse, Fluid & converter lining overheat

- Bushing failure • Poor line rise in Drive or Reverse

Wear at the inner bore results in excess pressure and reduced cooler/converter flow. Boost sleeve wear allows oil loss, resulting in poor line rise.

This oversized pressure regulator valve and boost assembly allows the valve body bore to be restored to normal operating condition.

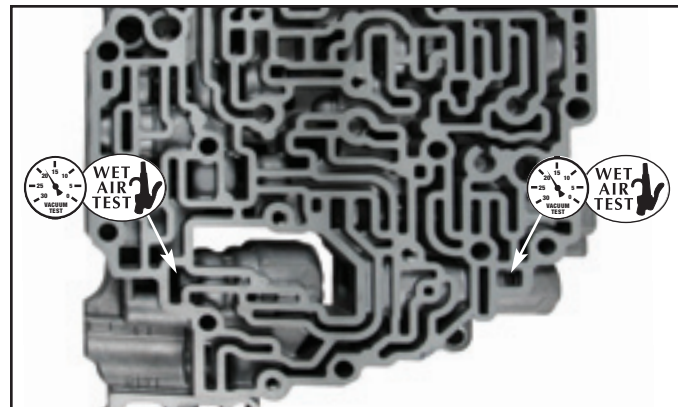
Either a Wet Air Test or a Vacuum Test in the two locations shown, result in leakage. A vacuum test must hold a minimum of 18".
