Solenoid Modulator Accumulator Piston Kit

39741-14K

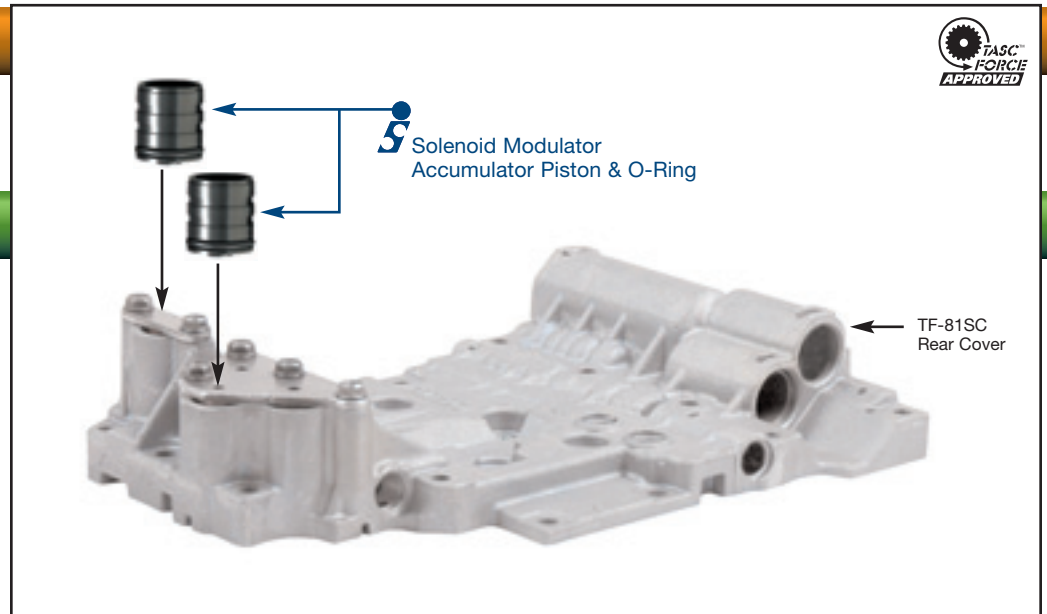
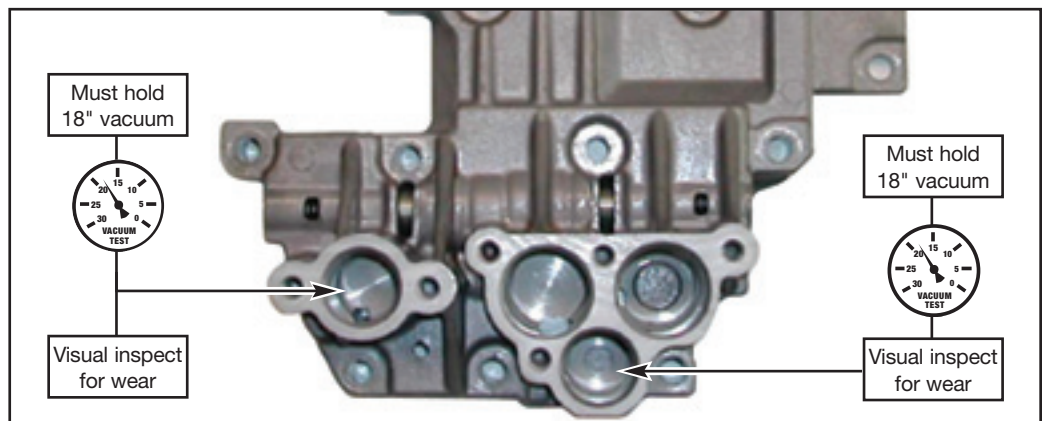
Visual inspection of the bore often shows shiny patches of wear. If wear is visible perform a Vacuum Test in the locations shown. Must hold minimum 18" of vacuum.
