Manual Valve

41750-03

Sonnax Part Summary

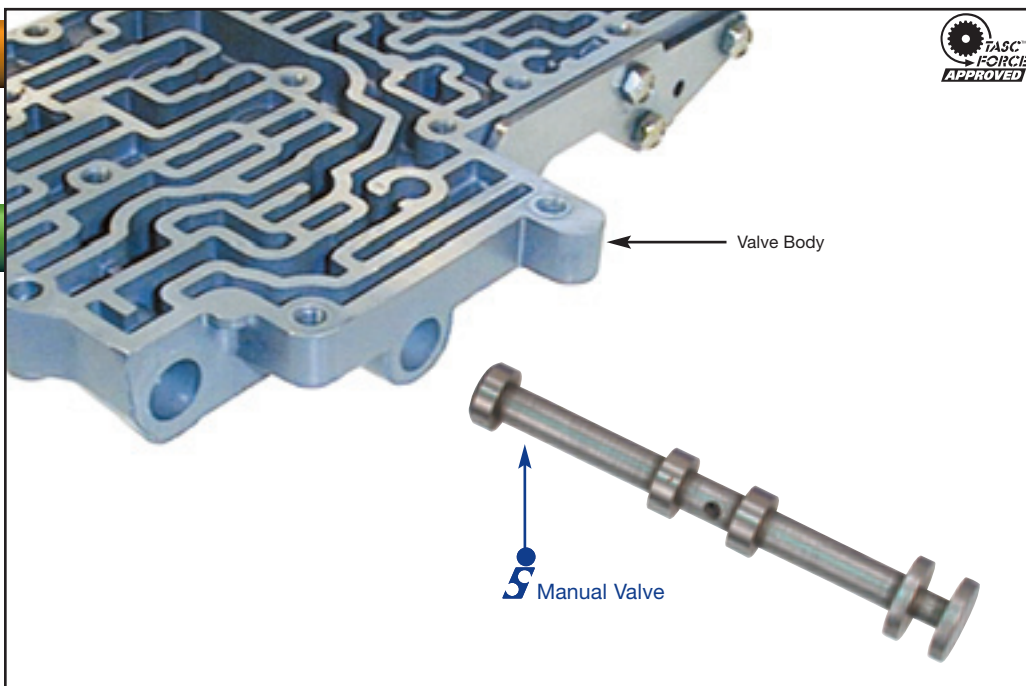
Delayed engagement, lube failures

- No cooler flow in park • Pump or converter hub bushing spin-out and/or converter overheating

Line pressure exhausts and does not charge the converter when the selector lever is in park.

This redesigned manual valve blocks line circuit oil from exhausting to the sump, increases converter charge pressure in park, and also redirects exhaust flow and reduces sump cavitation.

Note: Not recommended for some Hyundai applications. Do not use with .218" (5.5mm) ball in pump. Valve is calibrated to work with all units with .312" (8mm) ball in pump.
