Improved Bell Housing Bushing

54253-01

Sonnax Part Summary

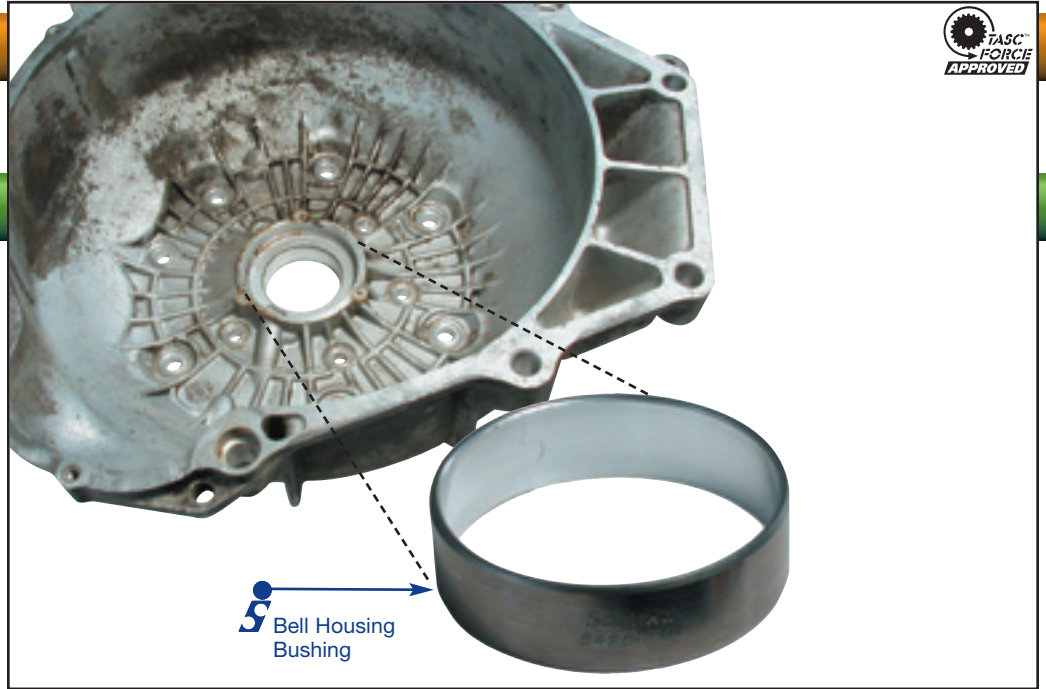
1 Bell Housing Bushing

Front seal leak

Normal wear and tear; replacement aftermarket bushings are too loose.

The bell housing bushing on the 4L30-E & 180C transmissions becomes worn due to normal wear. Excessive clearance between the bell housing bushing and the converter hub will cause a front seal leak. Simply replacing the metal-clad seal will not fix the problem. Current aftermarket bushings do not fit the converter hub tightly enough and can have more clearance than a worn OEM bushing. The new Sonnax bell housing bushing **54253-01** is designed to fit the converter hub properly and eliminate front seal leakage.

Replace the worn bushing with this new more tightly tolerated bushing.
