TCC Modulator Sleeve & Plunger Assemblies

Sonnax Part Summary

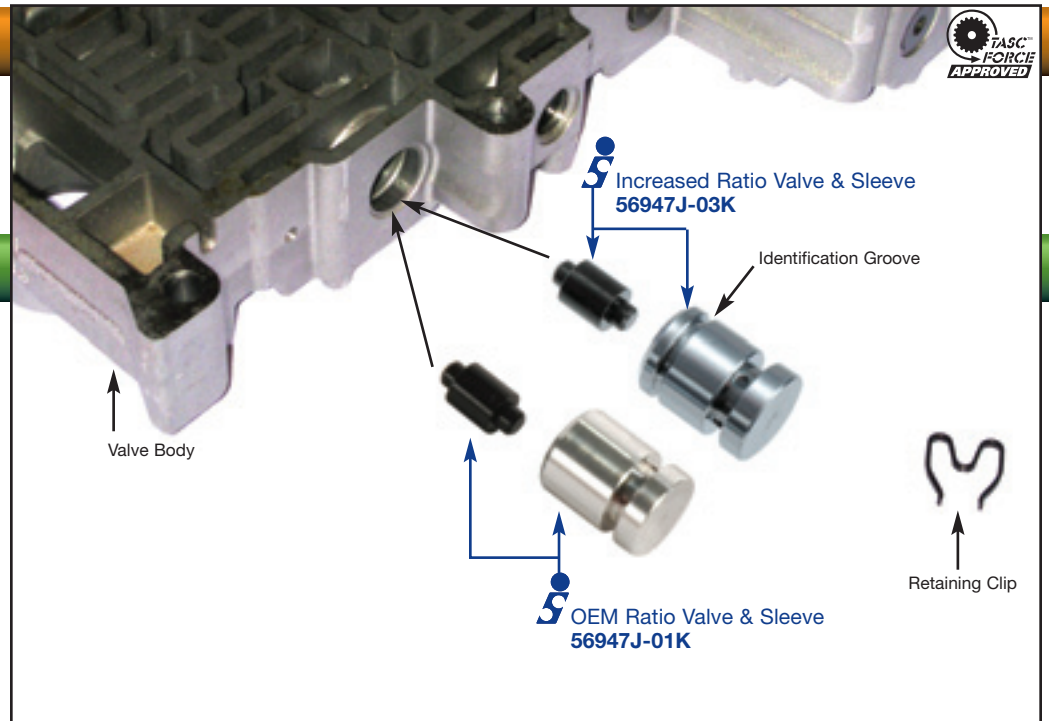
The plunger force is transferred onto the inner modulator valve. When the sleeve wears, the converter apply pressure is reduced and TCC slippage increases.

Note: The valve bore inward of this TCC modulator sleeve wears rapidly. Always inspect for bore wear at the largest spool of the inner valve.

The Sonnax assemblies restore proper hydraulic clearances so fluid pressure can position the TCC modulator valve to fully apply lockup. The increased ratio assembly provides a firmer and quicker lockup feel.
