TCC Modulator Valve & Sleeve

56947J-15K

5R55W/S
5R55N

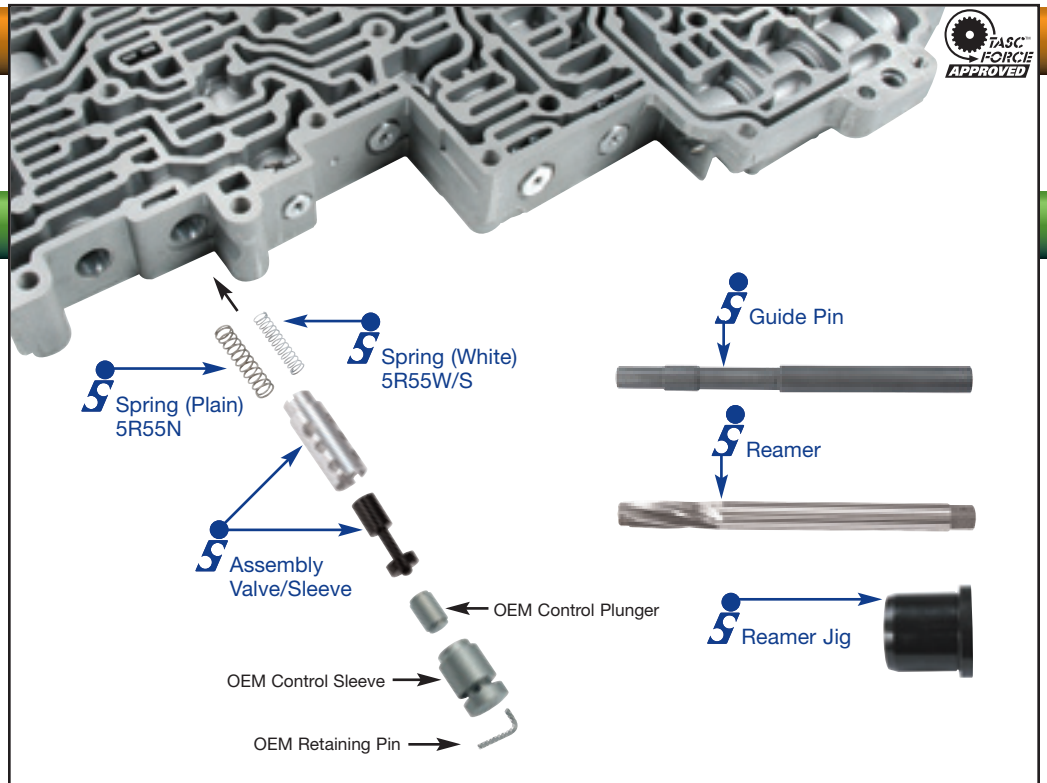
Excess TCC slippage

• Code 741 • Transmission over temperature conditions • Code 1783 • High line pressure

Bore wear at the TCC modulator reduces TCC apply pressure. The low apply results in increased TCC slippage.

The Sonnax valve and sleeve assembly restores proper TCC apply pressure by oversizing the bore and re-establishing clearances.

Note: The TCC modulator valve is stroked by a PWM solenoid through the use of a sleeve and plunger valve. These components are also prone to wear and should be inspected and replaced if necessary.
