Forward Engagement Valve Kit

56947J-26K

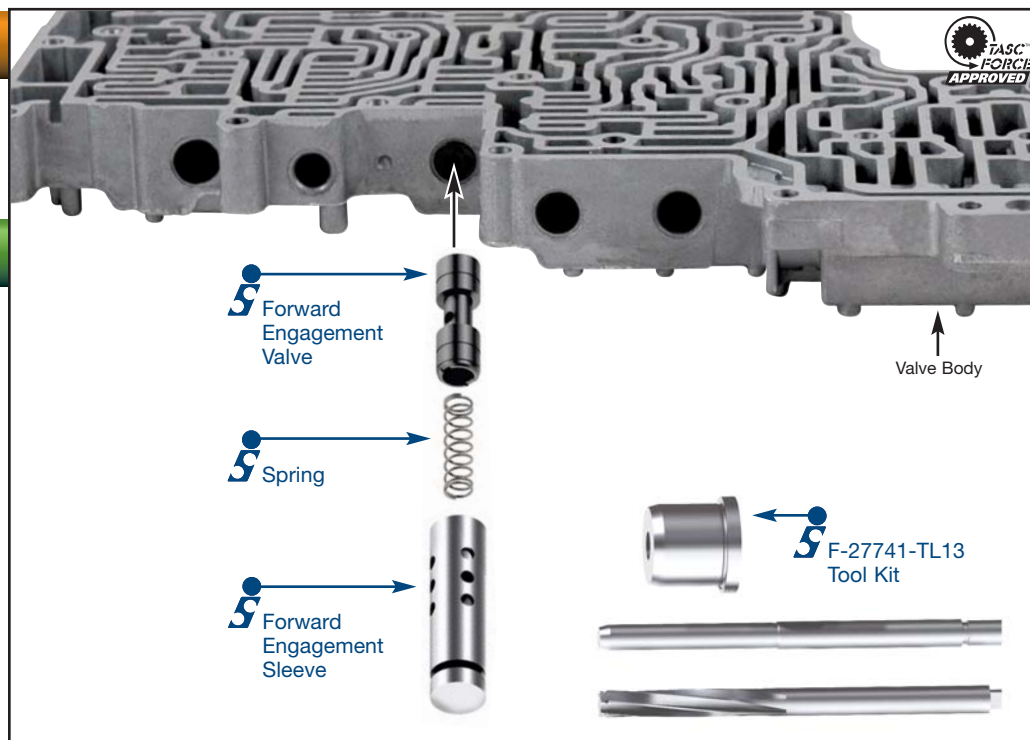
Wear at the forward engagement valve bore can prevent proper valve positioning, allowing forward clutch feed pressure to be reduced.

Line pressure from the manual valve is routed through the forward engagement valve in all forward gears prior to applying the forward clutch. Excessive wear at the valve bore or end plug can prevent solenoid feed oil pressure from correctly positioning the engagement valve or allow forward clutch feed pressure to exhaust. This reduced pressure can result in slipping or loss of forward gears, burned forward clutches or delayed forward engagement.

Refurbish the valve bore and install the Sonnax sleeve, valve and spring to restore proper hydraulic function and prevent future wear.

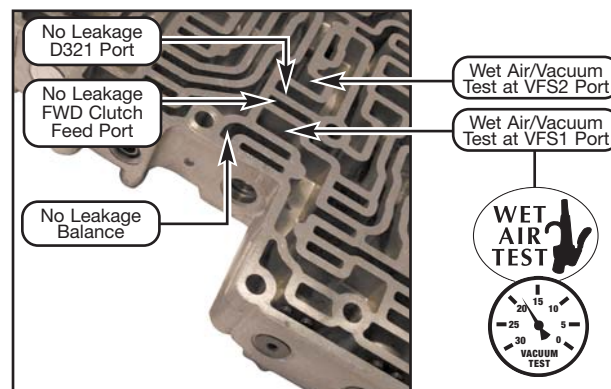
A Wet Air or Vacuum Test in the location shown, results in leakage.
A Vacuum Test should read a minimum of 18" vacuum.
