## Slipping or Loss of Reverse

## Reverse Engagement Valve Kit

### 56947J-29K

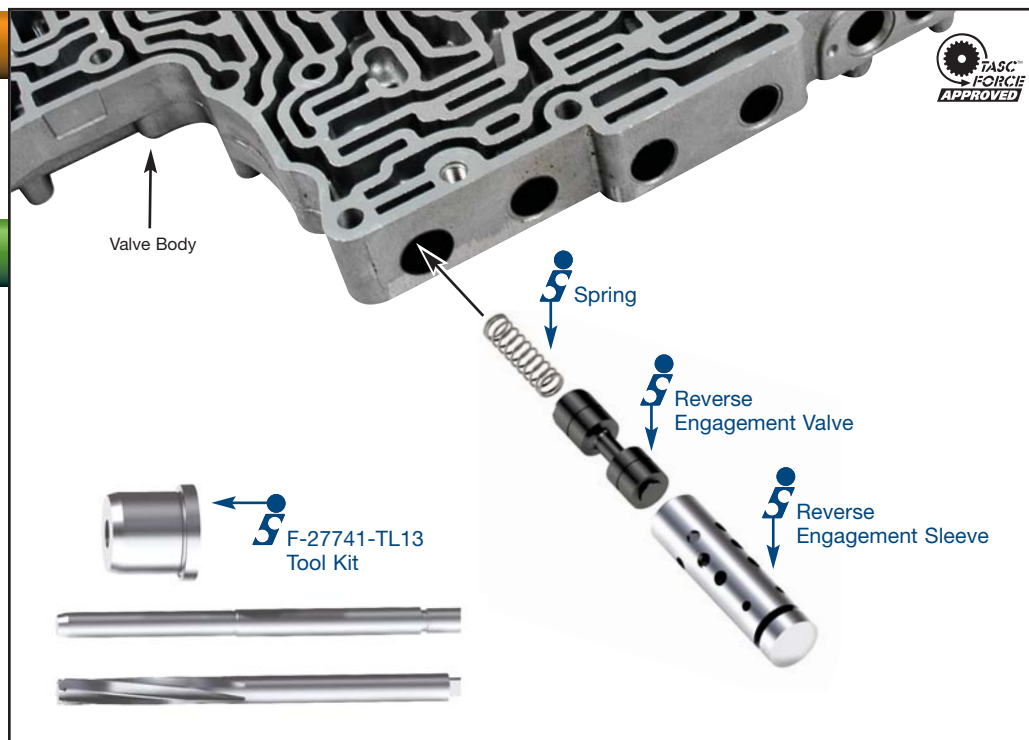
Wear at the reverse engagement valve bore can prevent proper valve positioning, allowing reverse pressure, which applies the direct clutch, to be reduced.

Refurbish the valve bore and install the Sonnax sleeve, valve and spring to restore proper hydraulic function and prevent future wear.

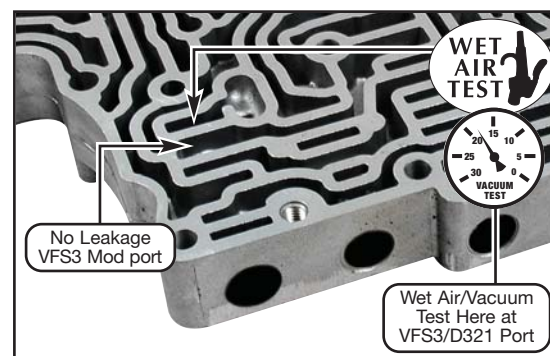
A Wet Air or Vacuum Test in the location shown, results in leakage. A Vacuum Test should reach minimum of 18" vacuum.
