COMPLAINT

Replacement Valve Springs

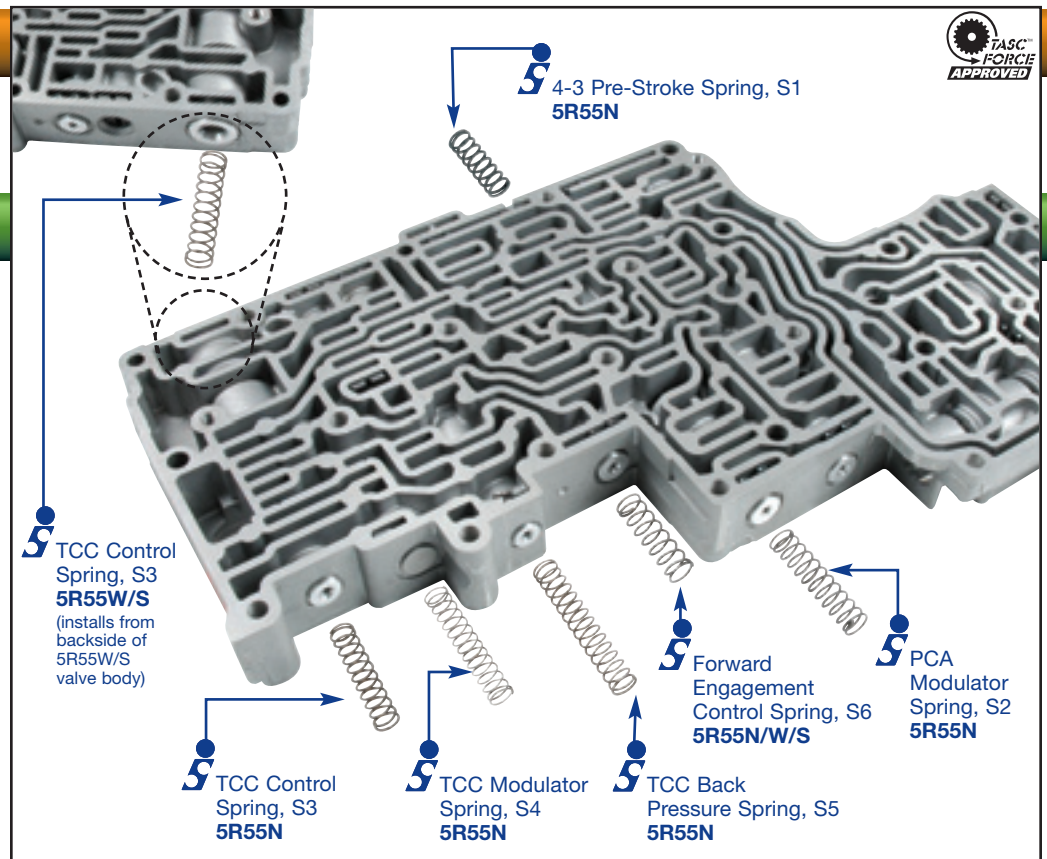
Spring replacement required due to bending, breaking or fatigue

The OEM valve springs are subject to breakage or fatigue failure, preventing proper operation of the associated valve.

The OEM valve springs are subject to breakage, bending or fatigue failure. Broken portions of the spring can cause the associated valve to stick in either the fully applied or released position. A fatigued spring will not have enough force to fully stroke the valve to the released position. Complaints vary depending upon specific location, but can be seen in chart below. The Sonnax springs will restore proper function to the associated valve when replacing a broken, bent or fatigued spring.

Replace the broken or fatigued OEM spring with the Sonnax replacement spring to restore proper spring rate.
