COMPLAINT

Spring replacement required due to bending, breaking or fatigue

Replacement Valve Springs

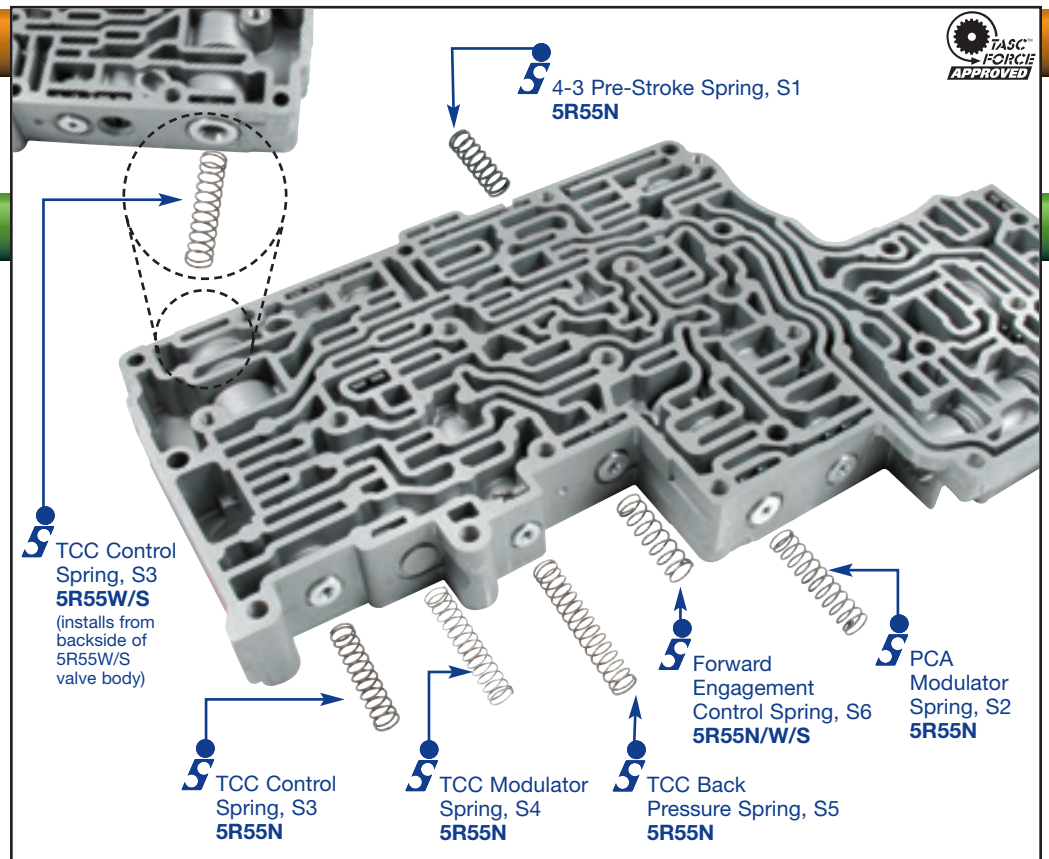
The OEM valve springs are subject to breakage or fatigue failure, preventing proper operation of the associated valve.

The OEM valve springs are subject to breakage, bending or fatigue failure. Broken portions of the spring can cause the associated valve to stick in either the fully applied or released position. A fatigued spring will not have enough force to fully stroke the valve to the released position. Complaints vary depending upon specific location, but can be seen in chart below. The Sonnax springs will restore proper function to the associated valve when replacing a broken, bent or fatigued spring.

Replace the broken or fatigued OEM spring with the Sonnax replacement spring to restore proper spring rate.
