Solenoid Relay Valve & Sleeve Kit

59947-05K

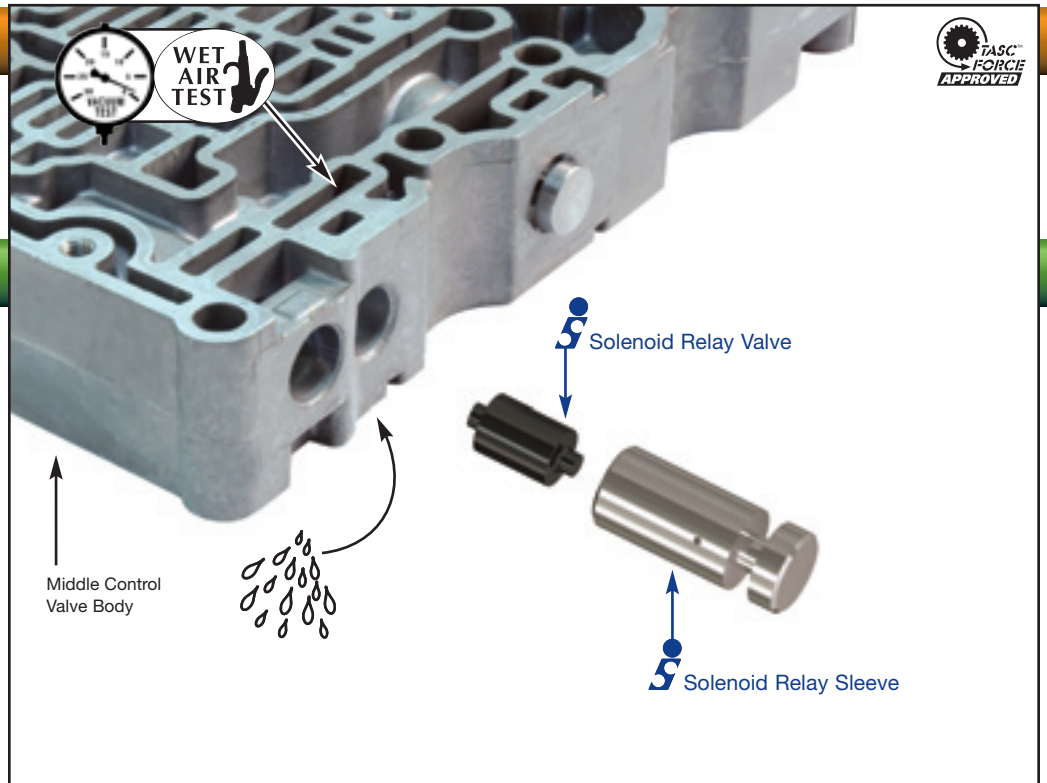
A vacuum test of the sleeve assembly (while in the bore at the outboard solenoid modulator feed port indicated) gives less than 18" of vacuum, or if a Wet Air Test at the same location results in leakage at the neighboring exhaust port on the opposite side of the casting.
