Main Boost Valve & Sleeve Kit

59947-07K

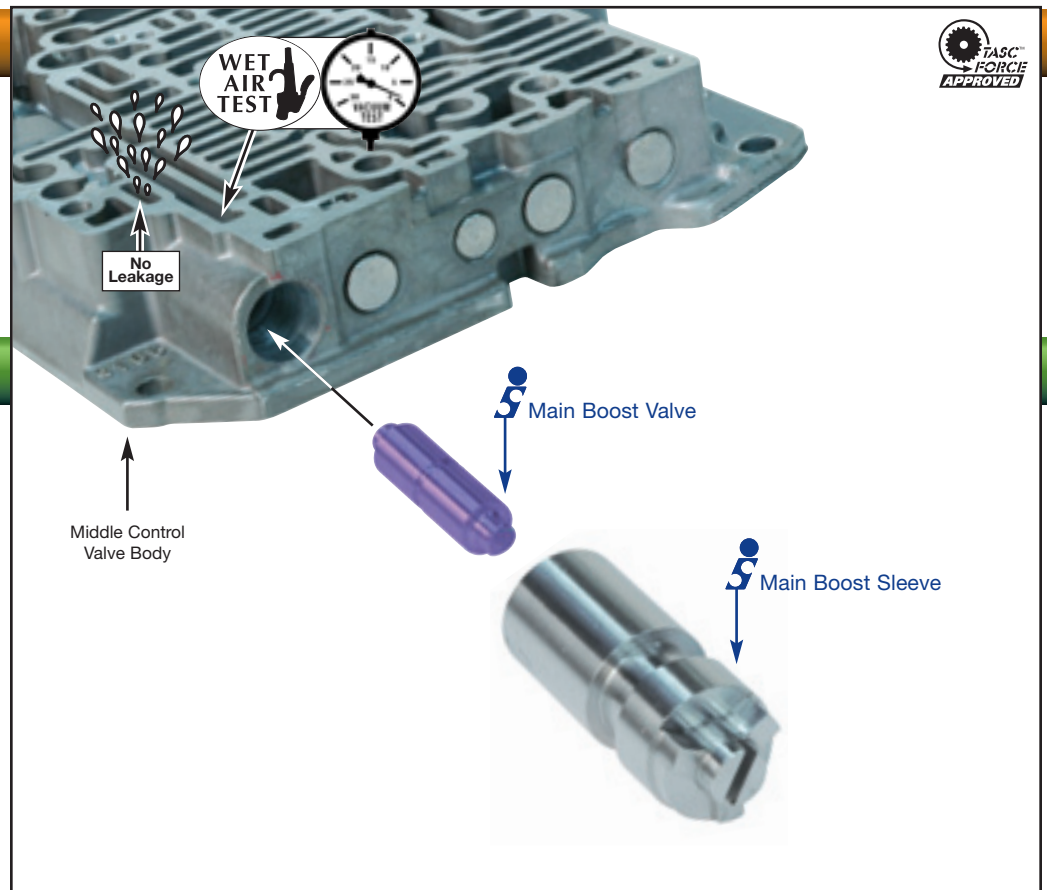
Delayed engagement in reverse or drive ranges

- Harsh/soft upshifts
- Erratic reverse pressure

The valve within the sleeve separates reverse boost oil from throttle signal (SLT) oil. Pressure in reverse can either be delayed or added to SLT, which results in very high reverse pressure. If the sleeve is worn and selector is not in Reverse, SLT is allowed to vent at the manual valve, reducing line rise, which affects engagements and shift quality.

A vacuum test of the sleeve assembly (while in the bore at the outboard reverse feed port indicated) gives less than 18" of vacuum, or if a Wet Air Test at the same location results in leakage at the neighboring exhaust port.

The tightly tolerated, drop-in replacement Sonnax valve and sleeve assembly restores proper hydraulic clearances and uses upgraded materials to prevent wear.
