Oversized Pressure Regulator Valve & Boost Valve Kit

59947-12K

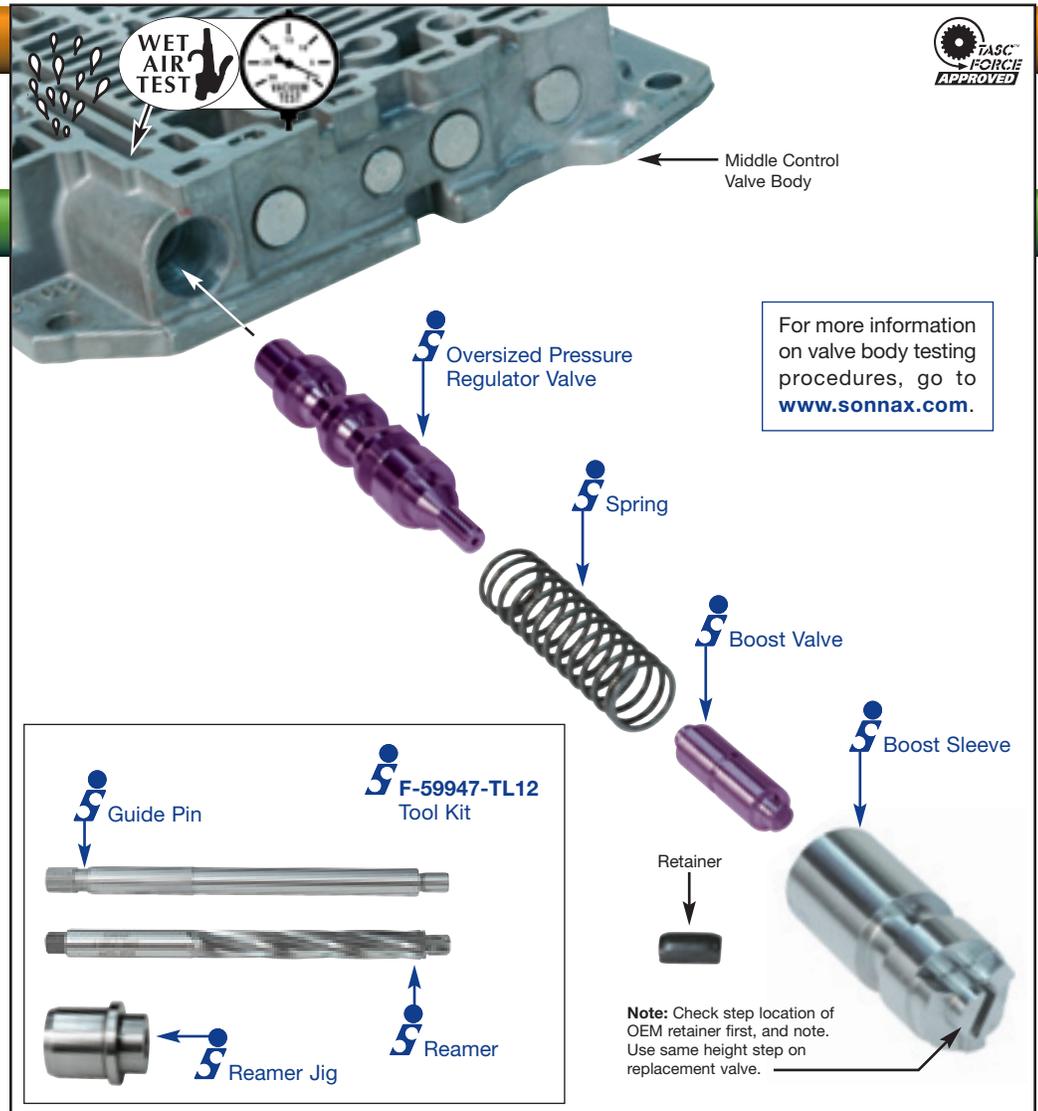
Wear at the main/primary pressure regulator valve bore

Wear at multiple points in the pressure regulator bore causes loss of pressure control.

Wear at the balance end can cause harsh shifts, high line pressure, converter apply/release problems and lube-related issues. Wear at the other locations can result in soft shifts, low line pressure, and converter problems. Boost sleeve wear reduces the ability of line pressure to rise according to TCM command, resulting in slow line rise and late shifts. Late shifts can often create gear ratio codes. A worn boost sleeve in this unit can also cause a delay in reverse or slippage, eventually burning the low reverse (B3), 1-2 reverse (B5) band and or the direct clutch (C2).

The Sonnax kit includes an oversized pressure regulator valve to restore correct clearances for proper hydraulic control, and a replacement boost valve assembly.
