Oversized Pump Bushing

68004-02

Sonnax Part Summary

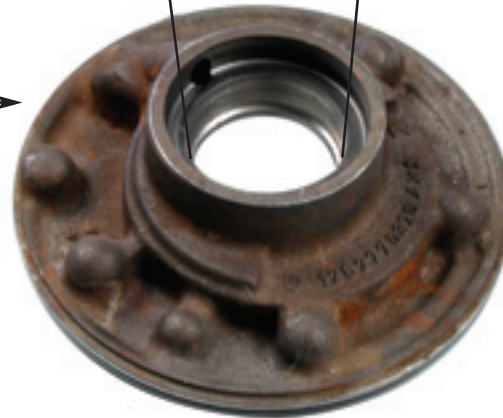
Pump leaks, bushing spins in housing, loss of pump core

Drive plate, converter pilot or hub run-out causes excessive load on the OEM bushing.

Finish-in-Place
Pump Bushing

Pump Housing

The Sonnax oversized finish-in-place bushing allows the salvage of damaged pumps while giving precise bushing-to-shaft clearance.

NOTE
Machining
required.
