## Harsh, bumpy or flare shifts

## Overlap Control Valve Sleeve Kits

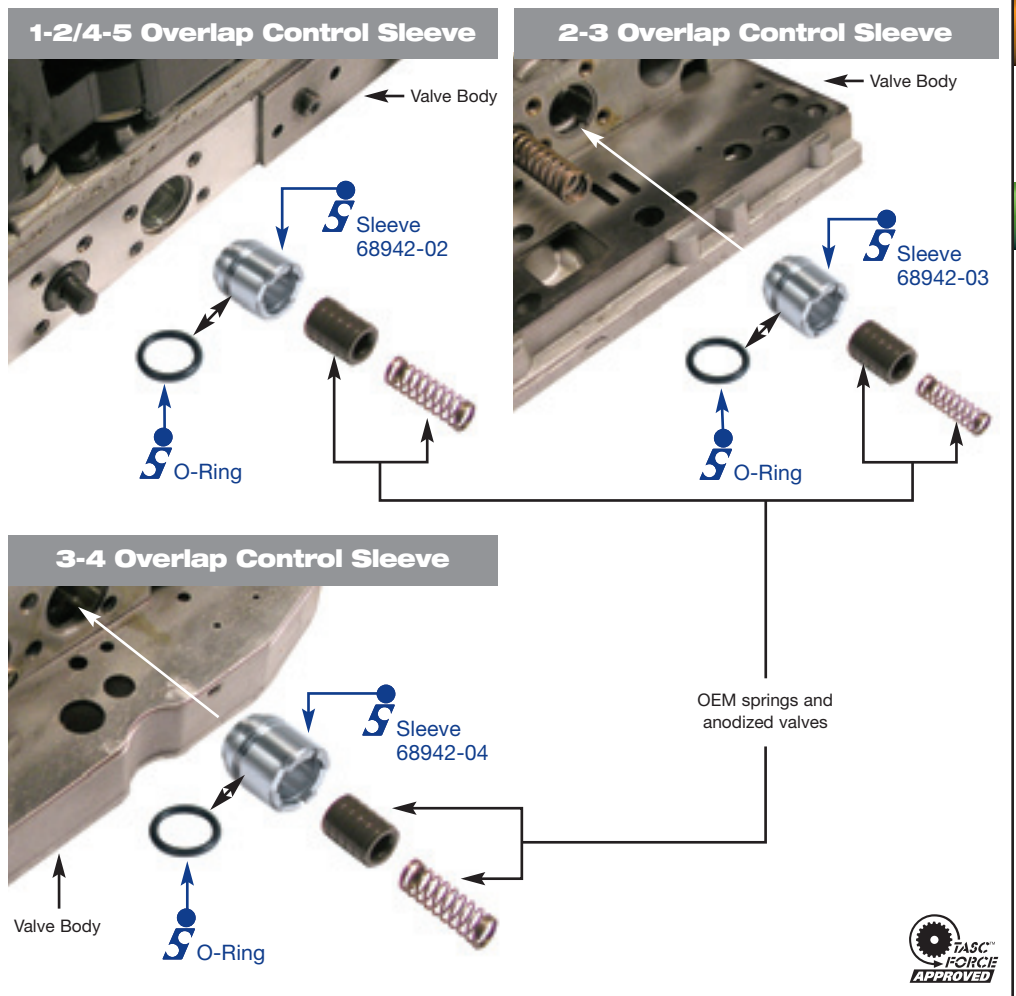
Wear at the 1-2/4-5, 2-3 and/or 3-4 overlap control valve sleeves allows modulating oil pressure to exhaust.

Continuous plunger valve oscillation causes wear at the 1-2/4-5, 2-3 and/or 3-4 overlap control valve sleeves, allowing modulated oil pressure to exhaust or oppose the shift and create numerous shift complaints. The highly wear-resistant Sonnax replacement sleeves restore necessary hydraulic control tolerances, and have external o-rings to provide additional positive sealing in the bore. The OEM springs and anodized valves can be reused.

These modulating sleeves position the valve for proper clutch feed. Sleeve kits correct the wear condition and restore control of clutch pressure apply or exhaust.

**68942-05K** Overlap Control Sleeve Kit  
3 Sleeves (1 for each location)  
3 O-Rings
