Oversized Regulating Valve Pressure Control Valve Kit (Early & Late)

68942-17K

Sonnax Part Summary

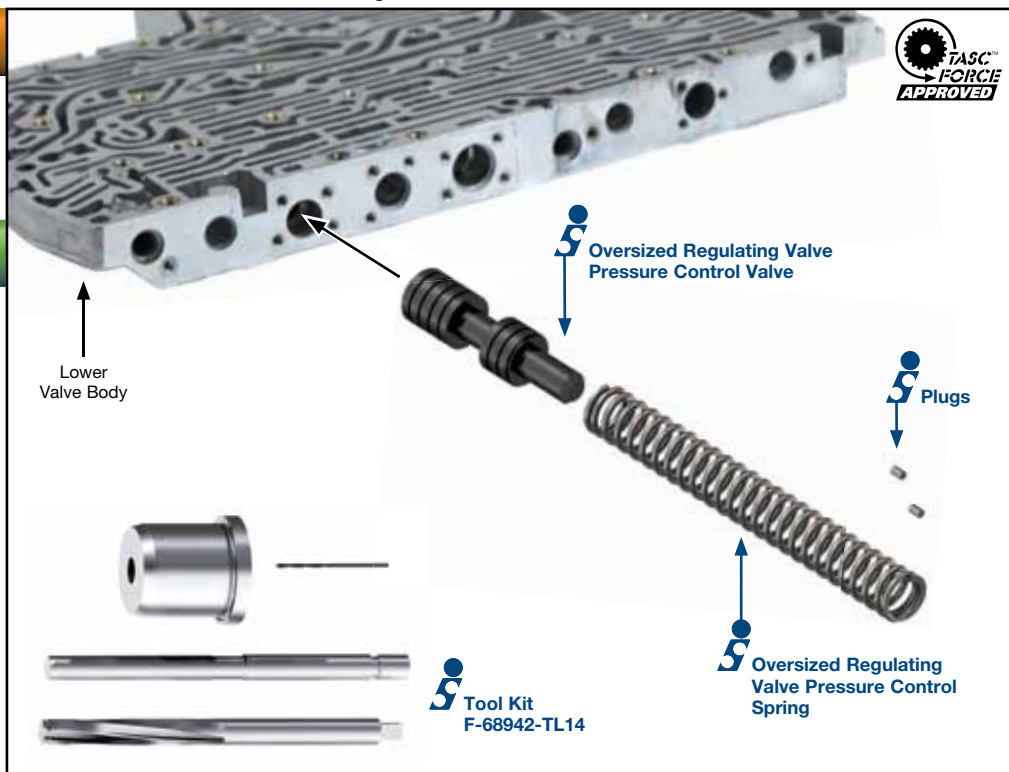
Bore wear reduces available pressure to both the pMod and pS control solenoids. Low pressure at these solenoids will reduce line boost and clutch feed pressure.

Severe wear of the regulating valve pressure control valve bore results in shift quality and solenoid control issues. The Sonnax kit **68942-17K** salvages these valve bodies.

Oversize the bore and install the replacement valve and calibrated spring to re-establish hydraulic integrity.

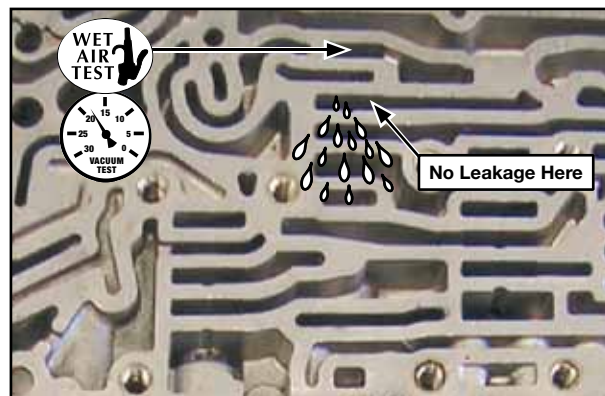
A Wet Air or Vacuum Test in the location shown, results in leakage. A Vacuum Test must hold a minimum of 18".
