1-2/4-5 Overlap Valve Kit

68942-19K

Sonnax Part Summary

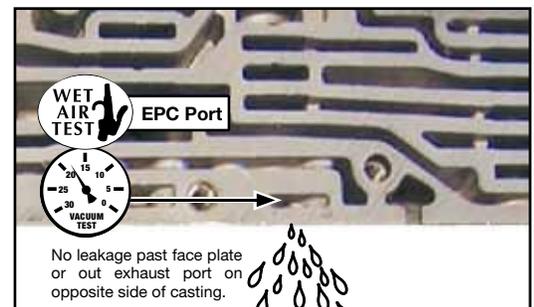
Wear at the overlap valve bore prevents proper exhaust of the disengaging clutch pressure, altering the precise timing required in the clutch-to-clutch shift transition.

A Wet Air or Vacuum Test in the location shown, results in leakage. A Vacuum Test must hold a minimum of 18". If you cannot effectively perform a WAT or Vacuum test, visually inspect the inboard overlap bore.

The improved Sonnax overlap valve kit restores hydraulic sealing and valve timing when installed in a refurbished bore.
