Pump Rebuild Kit

71912-01K

Sonnax Part Summary

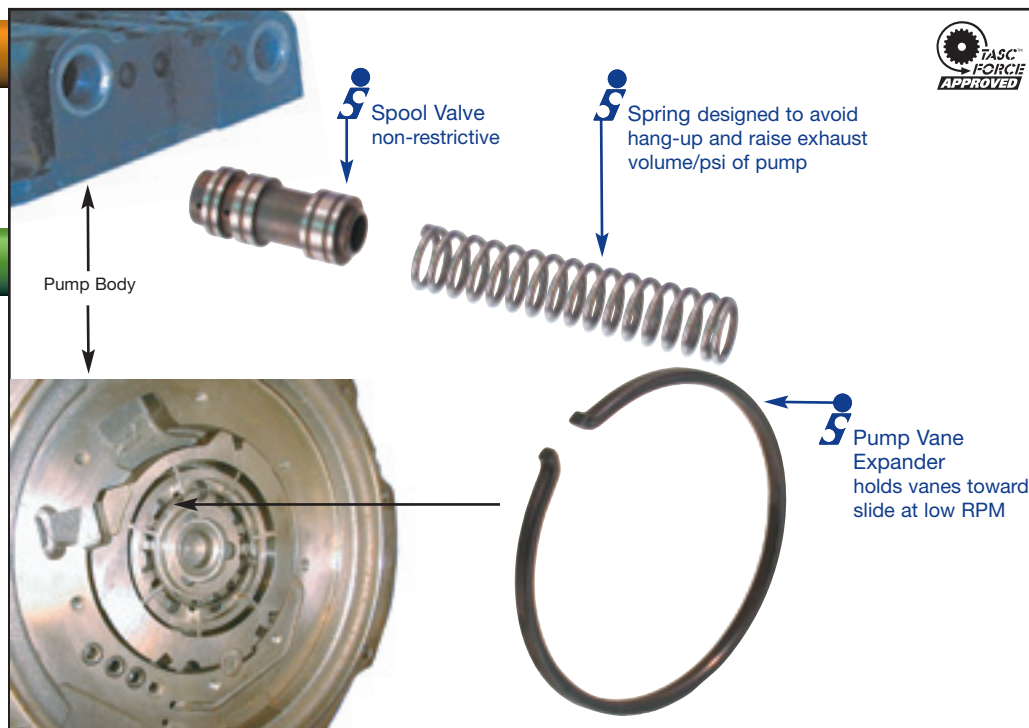
2-3 shift flare, low line pressure and pump volume

• Severe overheating • Converter burn-up • Spool valve and spring bore hang-up concerns

The pump is unable to produce sufficient volume because the spool valve has stroked to supply decrease oil to the pump slide.

The Sonnax spool valve has a non-restrictive center hole along with an improved spring to allow more oil to flow before the spool valve moves to open decrease oil to the pump slide. The vane expander increases pump volume by decreasing internal oil leakage.

1 Spool Valve
1 Spool Valve Spring
1 Pump Vane Expander
