Oversized PR Valve and Boost Valve Assembly Kit

72754-03K

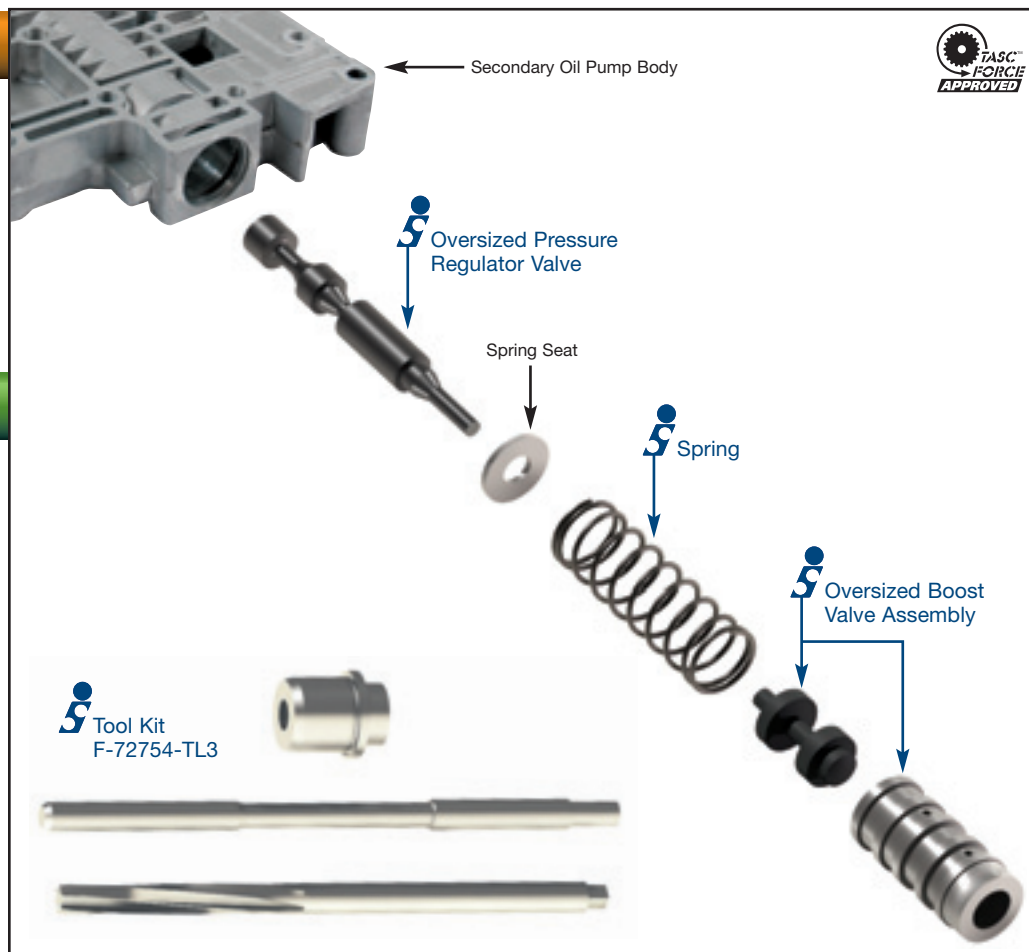
F-72754-TL3

Wear at the pressure regulator bore, especially at the balance end, results in the PR valve not being able to stroke to the lower line pressure position. This results in high line pressure. Leakage of line to exhaust reduces line rise. Slow line rise in response to engine load eventually burns a clutch or reduces TCC apply pressure.

Refurbish worn bores using the specially designed F series tool kit and the Sonnax VB- FIX and install the Sonnax oversized Pressure Regulator valve and boost valve assembly.
