## Worn accumulator piston pin bore or damage from broken spring

## 2-3 Accumulator Piston

### 72871-01

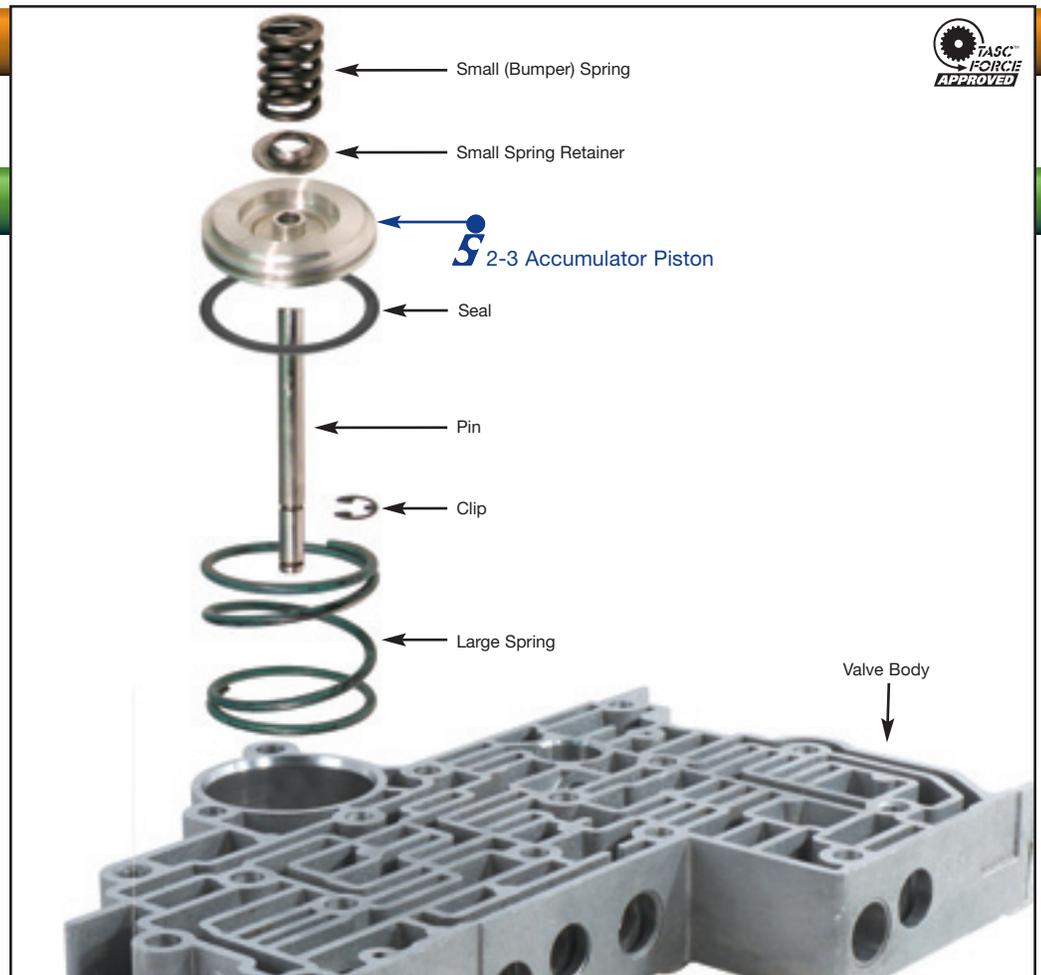
- 3rd clutch distress
- Soft 2-3 upshift or 4-3 kickdown

Normal wear and uneven loading from spring.

Install the Sonnax replacement piston with increased bore length for more piston-to-pin support and greater durability.

- This piston should not be used in a first-design 2-3 accumulator found in 1993 models. These units do NOT have the second “bumper spring” on the top portion of the accumulator piston.
- If the large spring is broken, replace with GM part number 8684827
