**O-Ringed
Accumulator
Piston & Spring
Kits**

Sonnax Part Summary

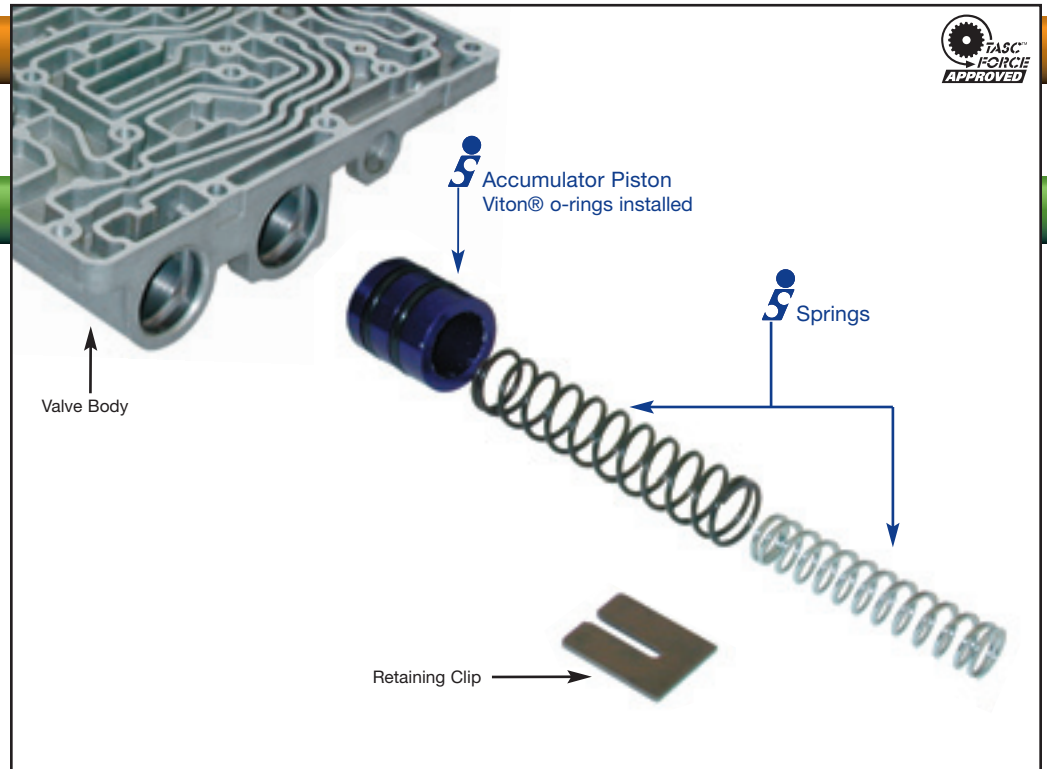
Accumulator bore wear and/or piston sticking

CD4E transmissions may exhibit such problems as harsh engagements, and/or soft or harsh shifting, particularly from first to second gear. These complaints can be due to worn or out-of-round accumulator bores and/or pistons sticking in the bore. Sonnax now offers an accumulator piston kit **73840-24** for the 2-4 piston, **73840-LR** for low/reverse, and **73840-FWD** for forward.

Prevent leakage of worn valve body castings with this o-ringed accumulator piston and spring kit.

- 1 Accumulator Piston
- 2 Viton® O-Rings
- Modified Springs
- 1 Rivet
