Valve Body Retainer Plate

76507F-01K

Sonnax Part Summary

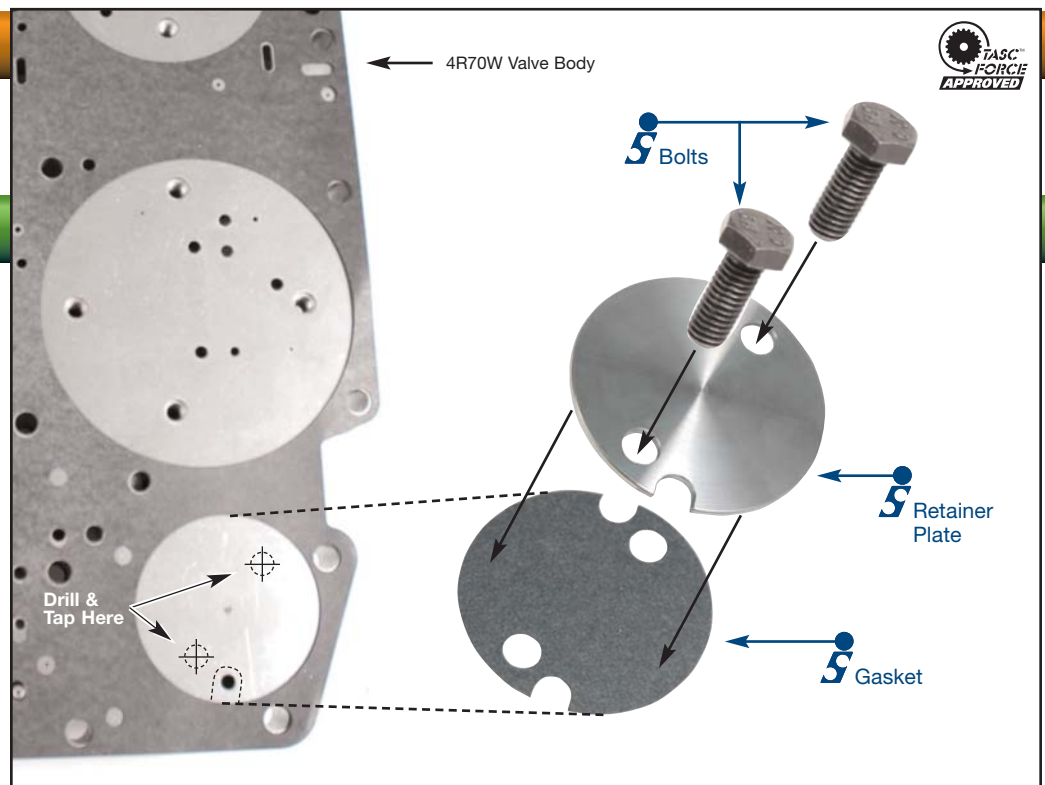
Cross leaks at valve body, separator plate cracking

Lack of reinforcement allows oil to push separator plate up, resulting in cross leaks and cracked plate.

The valve body stiffener plate in the 2-3 accumulator area was eliminated on 2001-up 4R70W & 4R75W transmissions. Oil pressure builds up in unused cavities under the separator plate causing the plate to flex upwards as much as .010", allowing forward and direct oil passages to cross leak. The Sonnax retainer plate 76507F-01K bolts in place and provides the clamping force to compress the lower valve body gasket. This prevents cross leaks, separator plate flexing and cracking, so that cracked separator plates can be reused.

This new Sonnax bolt-on plate provides mechanical clamping of lower valve body plate and gasket, eliminating cross leaks, cracks or plate flexing.

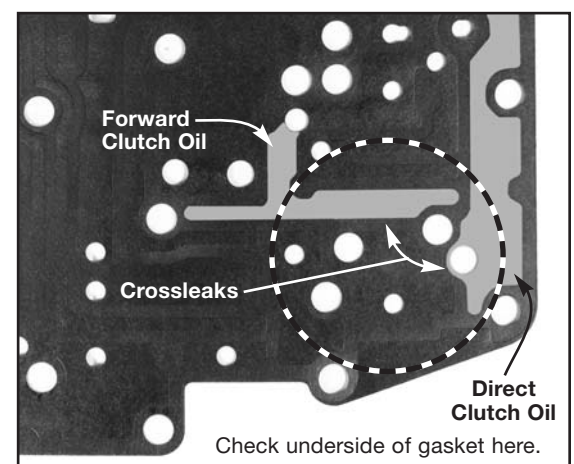
Upon inspection, there are signs of poor compression in the underside area of the used gasket. Poor compression indicates probable forward and direct oil cross leaks.
