1-2 Accumulator Sleeve & Piston Kit

76890-01K

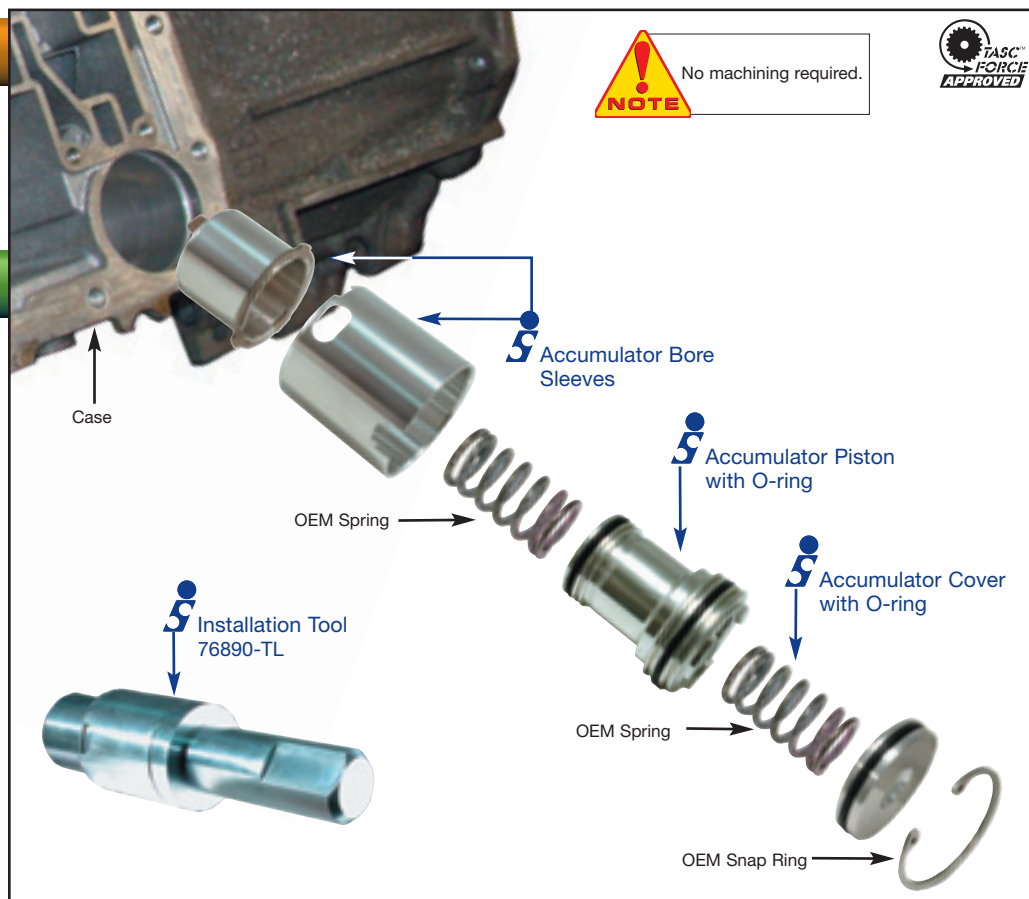
- Cases with worn or scored 1-2 accumulator bores

The 1-2 accumulator bore on AODE/4R70W cases can become scored, resulting in the loss of 2nd clutch pressure. Once this bore is damaged the case must be replaced.

This replacement piston and bore sleeve kit is a simple drop-in solution.
