## Forward clutch failure, low base line pressure

## Elevated Pressure Regulator Spring and Valve Kits

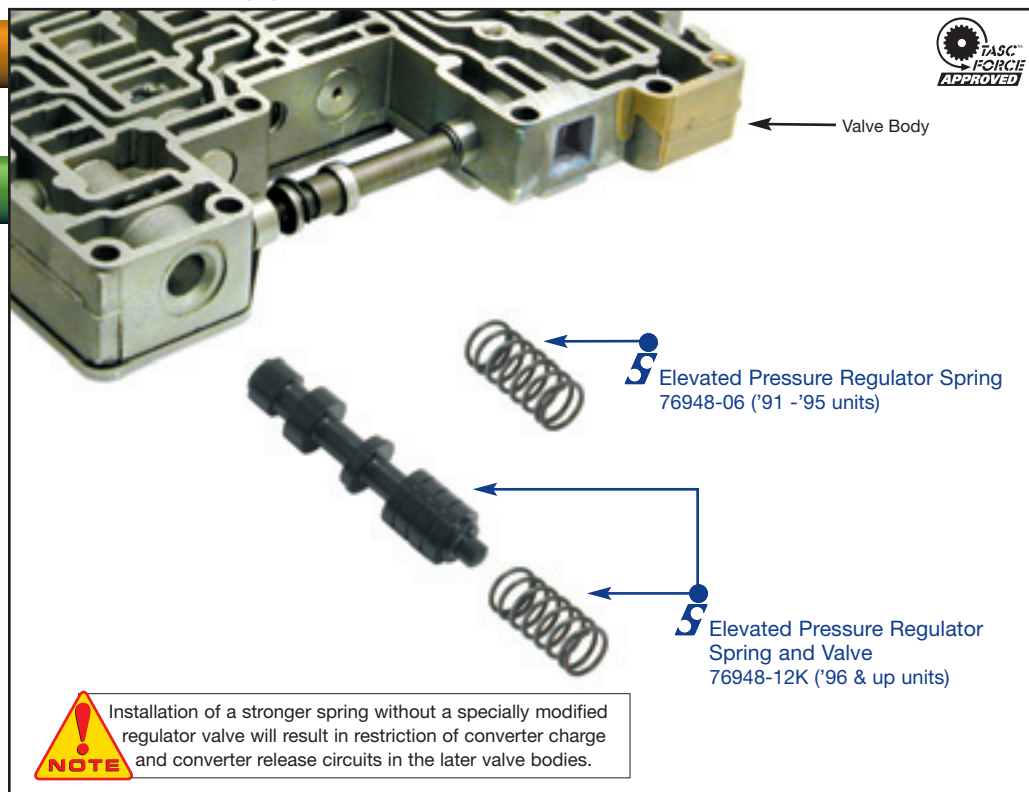
- Delayed forward engagement

Low line pressure.

Low line pressure in heavy-duty applications of Ford AODE and 4R70W transmissions results in forward clutch failure due to slippage. A stronger regulator spring is required to bring the base line pressure up to 68 psi in '91-'95 valve bodies with the early style pressure regulator valve. In 1996, Ford made a change to both the pressure regulator valve and valve body casting. The valve spool locations were changed slightly, and the spool diameter controlling line to converter feed was stepped. Due to these OEM changes, installation of a stronger spring without a specially modified regulator valve will result in restriction of converter charge and converter release circuits in the later valve bodies, and may cause the engine to stall or surge at an idle or create converter shudder.

Replace the existing spring with this stronger pressure regulator spring or PR spring and valve kit.
