## Premature clutch/band failure, poor reverse boost

## Pressure Regulator Valve & Boost Sleeve Kit

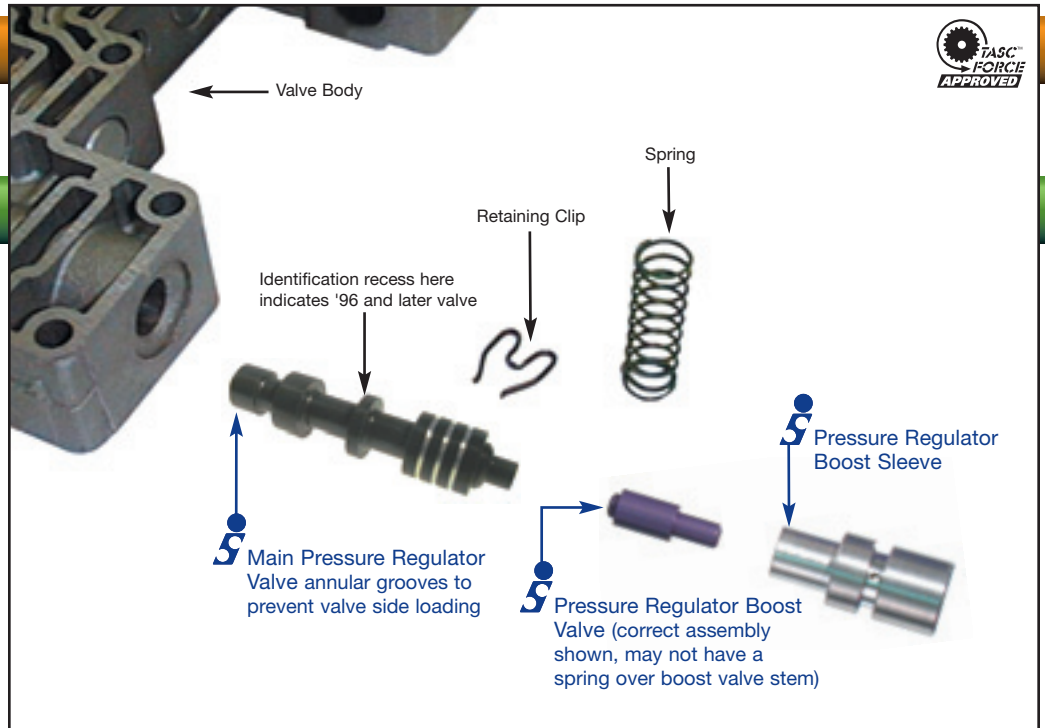
A worn main regulator valve and worn reverse boost sleeve.

A common complaint in vehicles with AODE/4R70W transmissions is low line pressure or throttle sensitive buzz, especially when hot. This is often caused by a worn main regulator valve. The valve frequently wears on the boost spool diameter and allows EPC (electronic pressure control) oil to leak to exhaust. This leakage results in poor line rise. When the oil temperature increases, the oil becomes less viscous and more leakage occurs. The two Sonnax replacement assemblies **76948-01** and **76948-09** eliminate the above problems with a direct replacement main regulator valve. Another common complaint with these transmissions is poor reverse boost, often the result of a worn pressure regulator boost sleeve. The sleeve should be checked while replacing the main pressure regulator valve. Sonnax offers a replacement pressure regulator boost valve and sleeve kit **76948-02K**.

These direct replacement main regulator valves prevent EPC oil from leaking to exhaust, while the replacement pressure regulator boost valve and sleeve kit restores the level of line rise required for reverse.
