## TCC slippage or loss of lockup

## Oversized Bypass Clutch Control Valve

### 76948-31

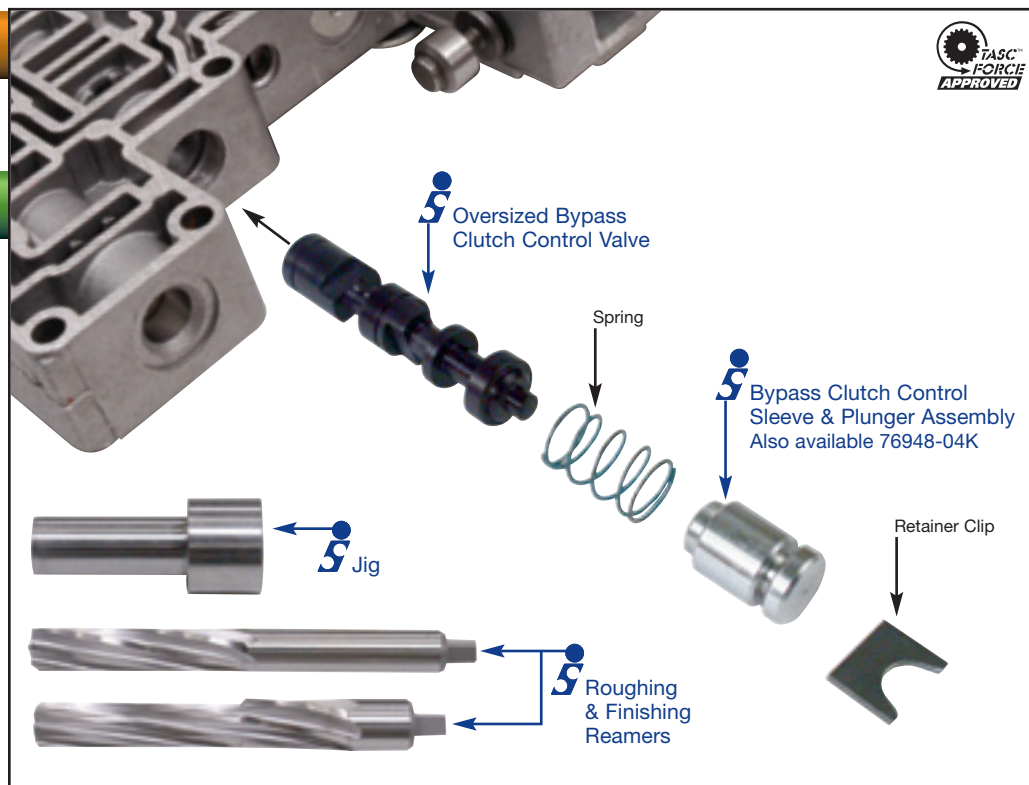
- Codes 628, 741, 1741 or 1744 • Reduced cooler flow

Excessive wear at the bypass clutch control valve bore.

TCC codes, shuttle or loss of lockup can indicate a bypass control problem. A worn bypass clutch control bore or valve will lower converter and TCC apply pressure. The Sonnax oversized bypass clutch control valve and tool kit salvages affected valve bodies, allowing you to ream the bore to accept the oversized valve, restoring proper function to the bypass control circuit.

Ream the valve bore and install the Sonnax improved oversized valve to replace the OEM version.
