Factory Style Throttle Valve Plug & Sleeve

76989-03K

Sonnax Part Summary

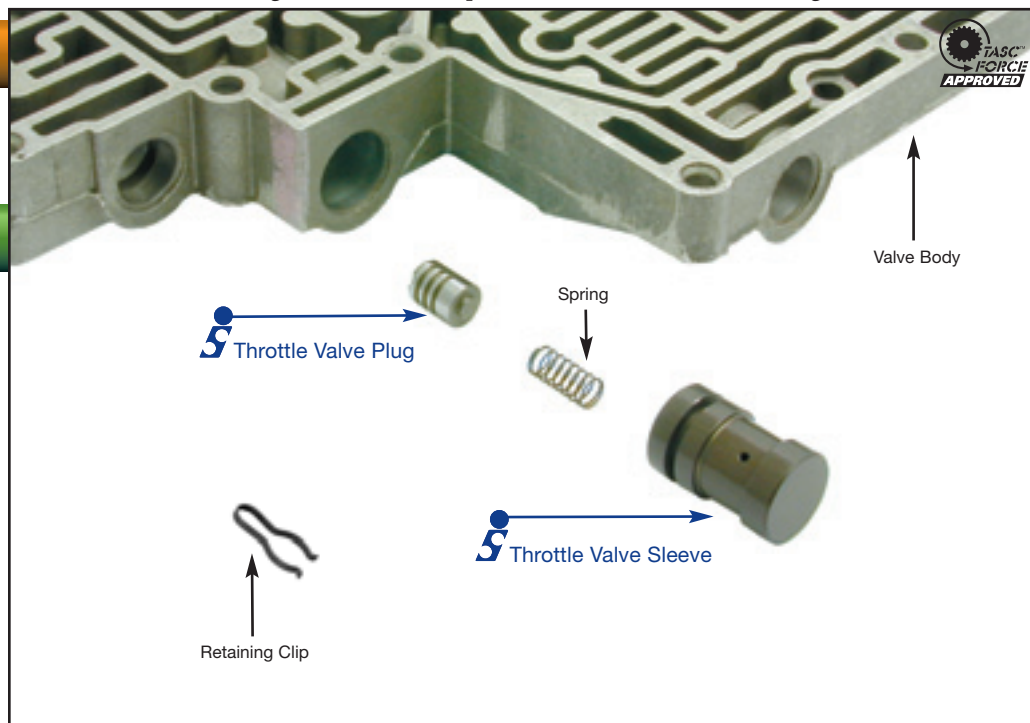
Insufficient line rise

- Uncontrollable shift timing • Imbalance of TV pressure • Clutch or band overheating

The throttle valve plug wears the sleeve, allowing throttle valve feed oil to leak past the plug and exhaust

Uncontrollable throttle pressure due to oil loss is a common complaint in vehicles with an AOD transmission. This results in low line pressure and poor throttle and shift timing adjustments. The hardened steel throttle valve plug continuously reciprocates within the aluminum throttle valve sleeve, wearing the inside diameter of the sleeve. This wear allows throttle valve feed oil to leak past the plug and exhaust, resulting in poor line rise.

The replacement kit has been designed to eliminate excessive leakage and includes a tightly toleranced, wear-resistant sleeve.-

- Throttle valve plug and sleeve kit eliminates excessive leakage.
- Replacement sleeve has been manufactured from a special aluminum designed to prevent wear.
- Steel plug has been tightly toleranced to allow minimum clearance with the inside diameter of the sleeve, restoring hydraulic integrity to the assembly.
