“Factory Style” Boost Valve and Sleeve

76990-03K

Sonnax Part Summary

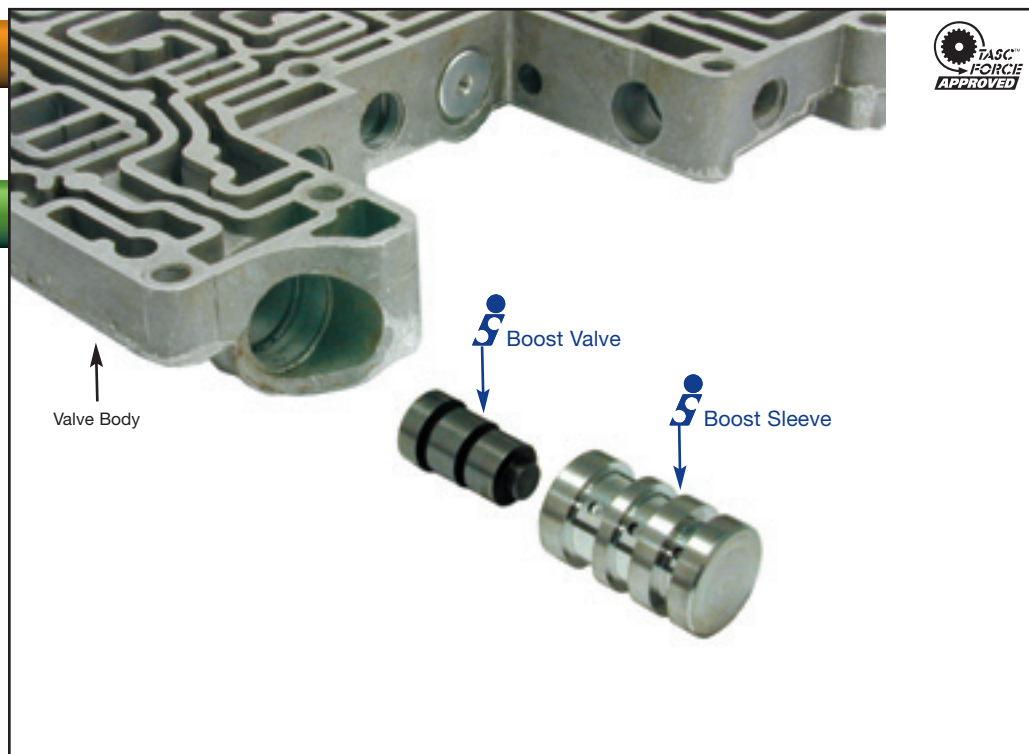
Direct clutch failure

- Insufficient line rise • Soft slide shifts, delayed reverse

Severe wear of the pressure regulator boost sleeve allows boost oil leakage.

This pressure regulator boost valve and sleeve kit is made from high-quality aluminum to prevent wear.

- 1 Boost Valve
- 1 Boost Sleeve
