Boost Valve & Sleeve

76990K

Sonnax Part Summary

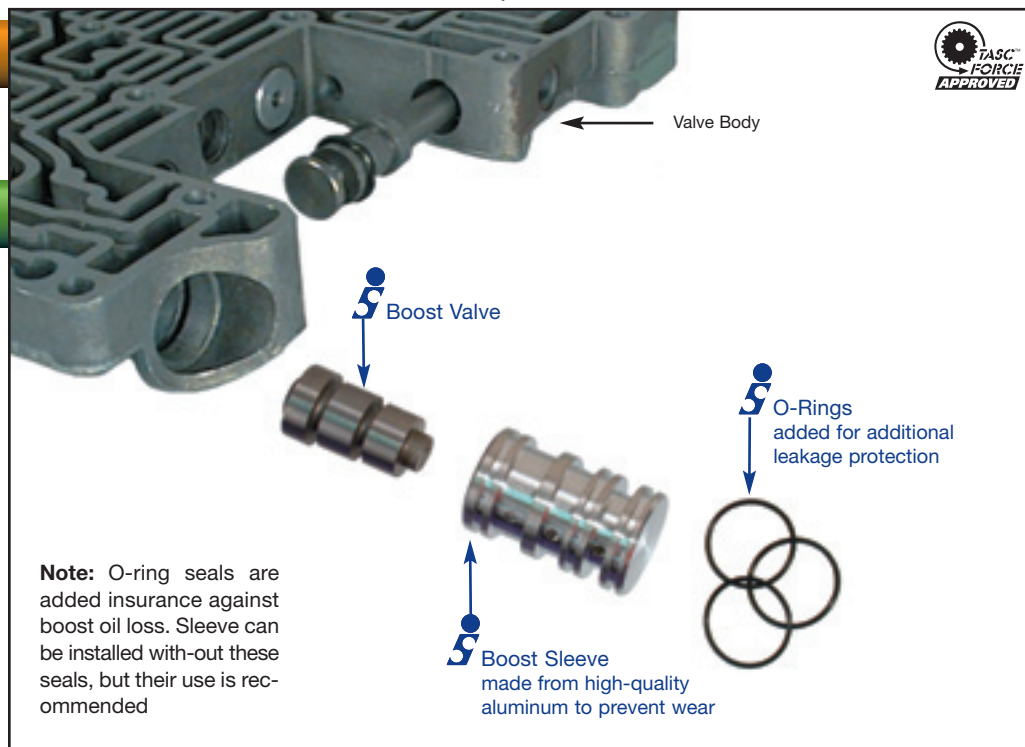
Direct clutch failure

- Insufficient line rise • Soft slide shifts, delayed reverse

Severe wear of the pressure regulator boost sleeve allows boost oil leakage.

This pressure regulator boost valve and o-ringed sleeve kit is made from high quality aluminum to reduce wear. Added o-rings prevent oil from escaping past the valve body bore.
