PART NUMBER 77010-01

### Wide Reaction Sun Gear Bushing

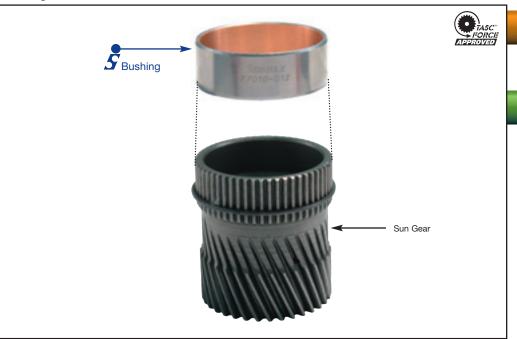
1 Wide Reaction Sun Gear Bushing

## Reaction carrier shaft damage

DARY COMPLAINT • Bushing failure

Oil leakage due to inadequate support of the reaction sun gear.

The Sonnax sun gear bushing is more than one-and-a-half times as wide as the OEM and maximizes bushing support.

The Sonnax replacement bushing 77010-01 is one-and-a-half times the width of the OEM version and fills the entire sun gear bushing groove. This wider bushing maximizes support. The bushing is steel-backed bronze that is precision machined to provide minimal clearance with the mating shaft.
