## Servo Release "Check Valve"

**77701-076**

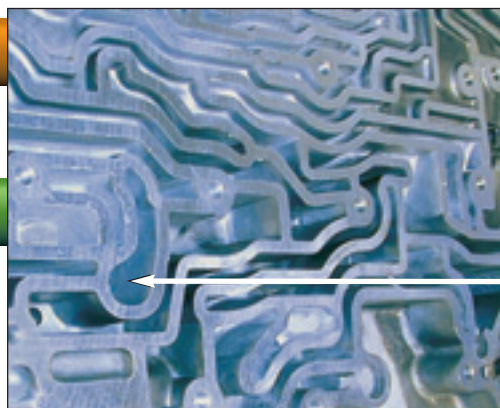
## Reduced 3-4 clutch life

- Poor 2-3 shift feel • 3-2 tie-up

Inadequate metering of the 2nd band servo release oil.

This part combines an orifice with a ball check valve to meter servo release oil.

Must be used with  
OEM capsule.

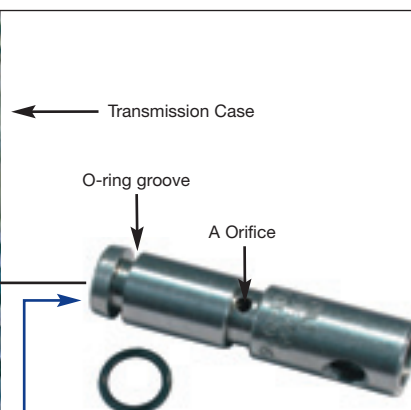
**Check Valve™**  
allows 3-4 clutch feed orifice calibration  
without creating 2-3, 3-2 concerns

**Note:** Enlarge "A" orifice to .120-.125" when used with Corvette 2nd gear servo piston (GM P/N 8642093) or any heavy-duty aftermarket servo piston.
