## Oversized Accumulator Pin & Reamer

**77754-01K**

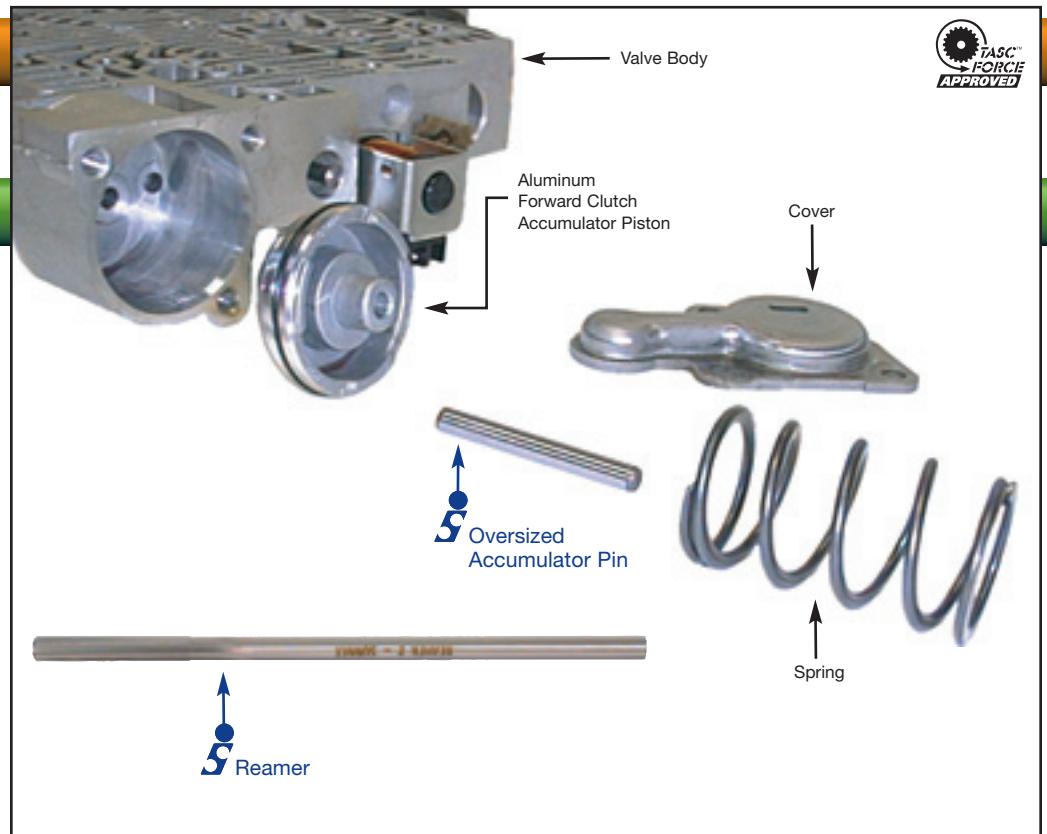
## Burned forward clutches

- Delayed engagements

A worn forward accumulator piston pin bore.

A common condition in 4L60-E transmissions is a burned forward clutch or delayed engagement. A worn forward accumulator piston pin bore is frequently the source of this condition. The aluminum piston continuously oscillates on a hardened steel pin, which can cause wear resulting in forward clutch oil exhausting. This oil loss reduces accumulator action and decreases the forward clutch apply pressure. The Sonnax replacement oversized accumulator pin 77754-01K eliminates this problem.

This oversized replacement accumulator pin restores the proper fit between the piston and the bore and allows re-use of the original aluminum piston.
