3-4 Clutch Boost Spring

77763-01

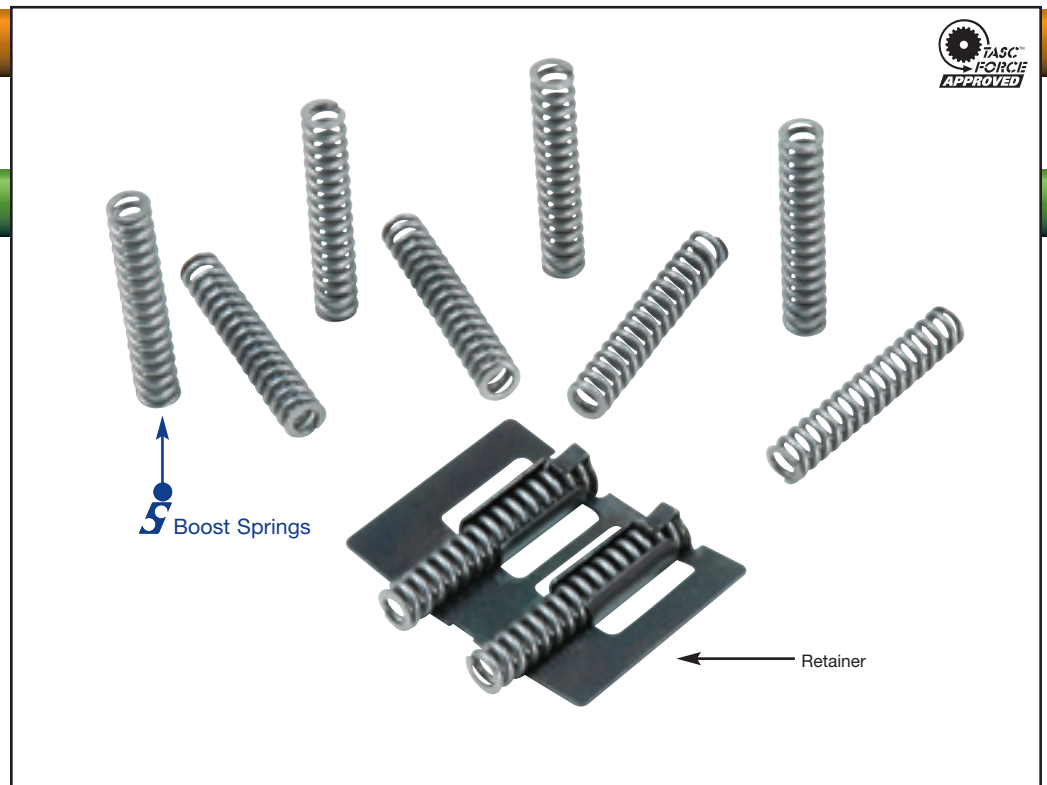
3-4 Clutch boost springs collapse and are ineffective once they have been overheated.

Springs collapse and lose strength when overheated due to 3-4 clutch failure.

Install these precision manufactured, direct replacement boost springs.
