## COMPLAINT

### 1-2 bang (light throttle) or end bump shift

## Accumulator Valve Train Assembly

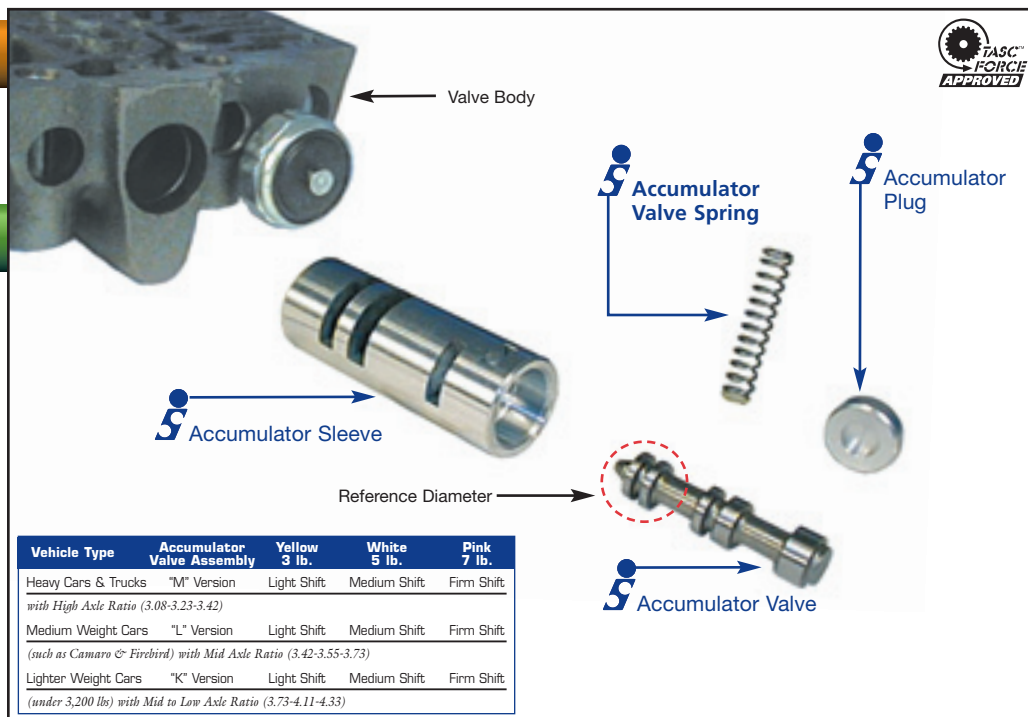
Accumulator control is incorrect for the vehicle application, and/or wear of the aluminum sleeve allows oil loss.

Using one of these three assemblies will eliminate oil loss and maintain holding power to ensure proper shift feel.

**77777M-K** .341"

**77777L-K** .330"

**77777K-K** .315"
