Shortened TV Link

77872-01

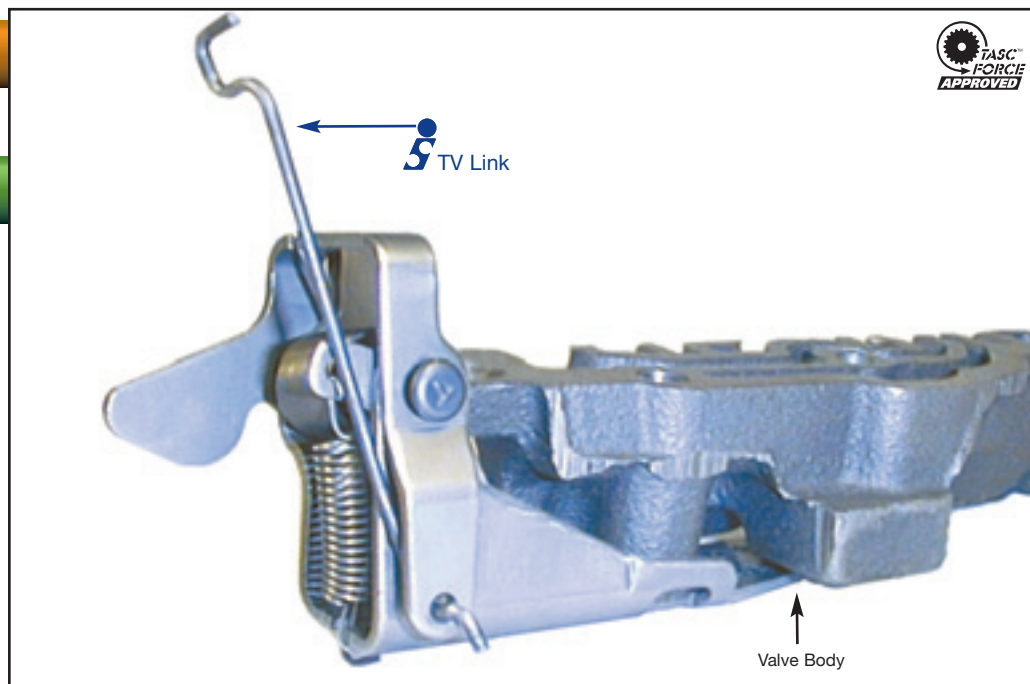
3-4 clutch/band failure

- Poor line rise • Soft shifts

The TV cable is out of adjustment.

The TV cable synchronizes engine throttle movement with TV plunger movement. If the cable is not readjusted to ensure proper line rise, the unit may return quickly with soft shifts and a burned 3-4 clutch or band. Sonnax has designed a throttle valve link **77872-01** that is shorter than the OEM, so that the installer must readjust the TV cable.

This shorter TV link ensures readjustment of the throttle cable and was designed with the carry-out unit in mind.
