"Factory Style" TV Boost Valve & Sleeve

Sonnax Part Summary

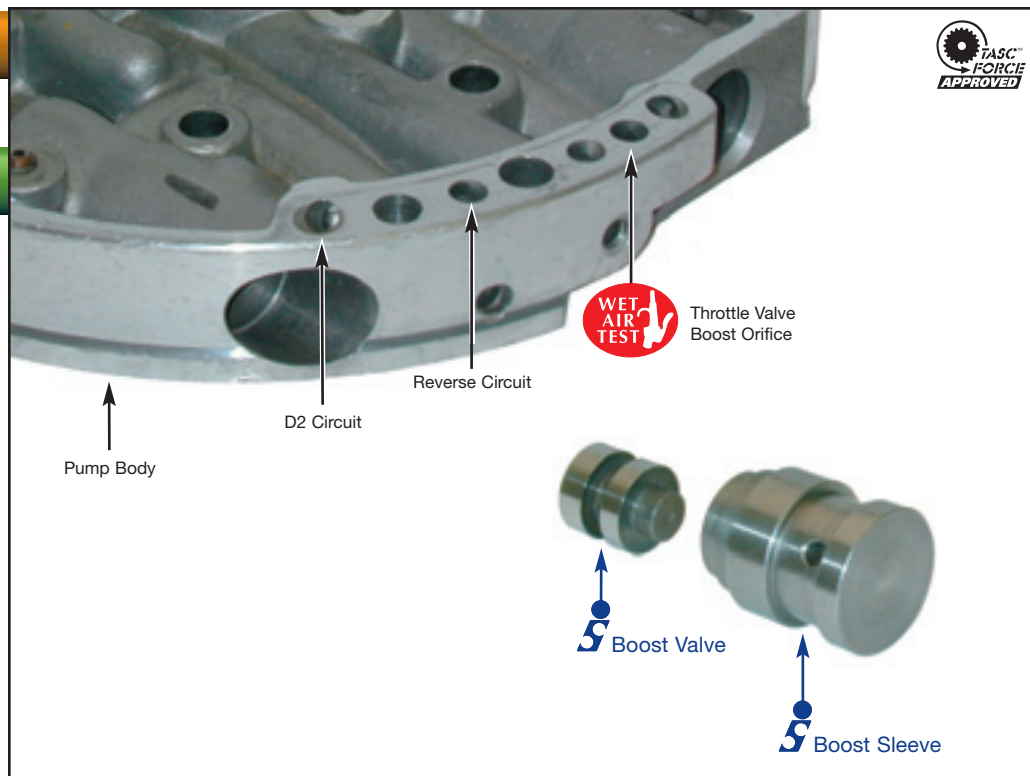
Burned 3-4 clutch

- Shortened band life • Soft slide shifts

MTV boost loss from insufficient line rise.

A common problem in 700-R4 transmissions is burned bands and/or 3-4 clutches. This failure can be reduced by eliminating throttle boost oil leakage. The Sonnax replacement assemblies 77917-02K, 77917-03K, and 77917-04K eliminate these problems.

Install the appropriate Sonnax TV boost valve kit.
