COMPLAINT

Sonnax Part Summary

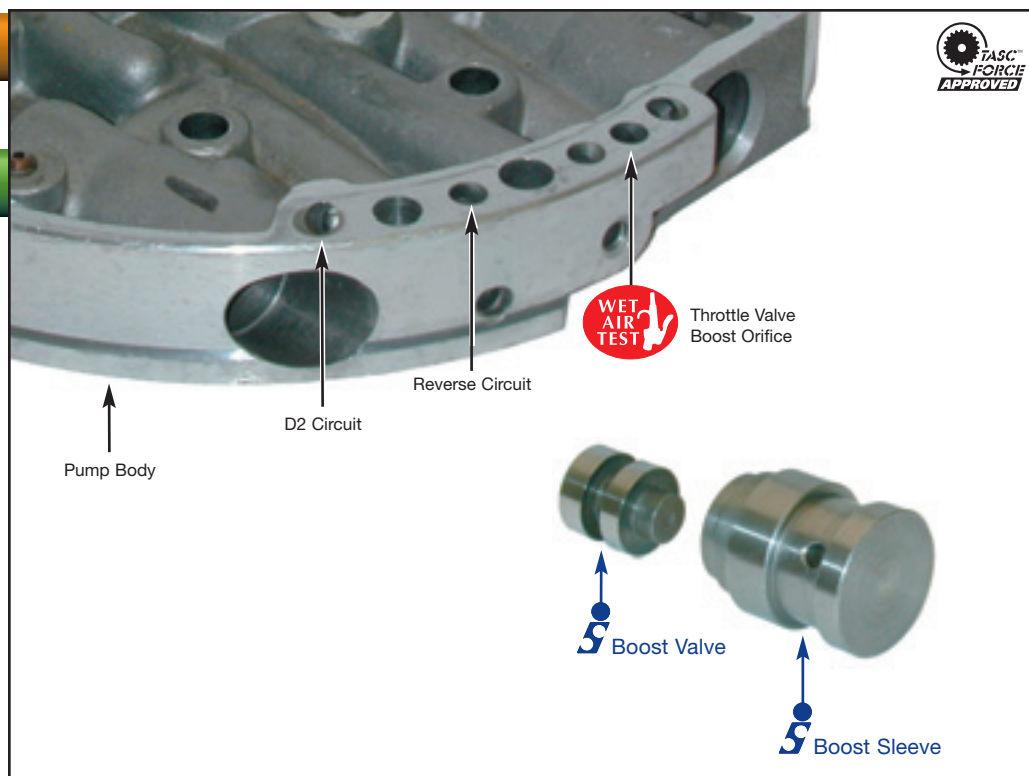
Burned 3-4 clutch

- Shortened band life • Soft slide shifts

MTV boost loss from insufficient line rise.

Install the appropriate Sonnax TV boost valve kit.
