## Throttle Valve Plunger & Sleeve Kits

### Sonnax Part Summary

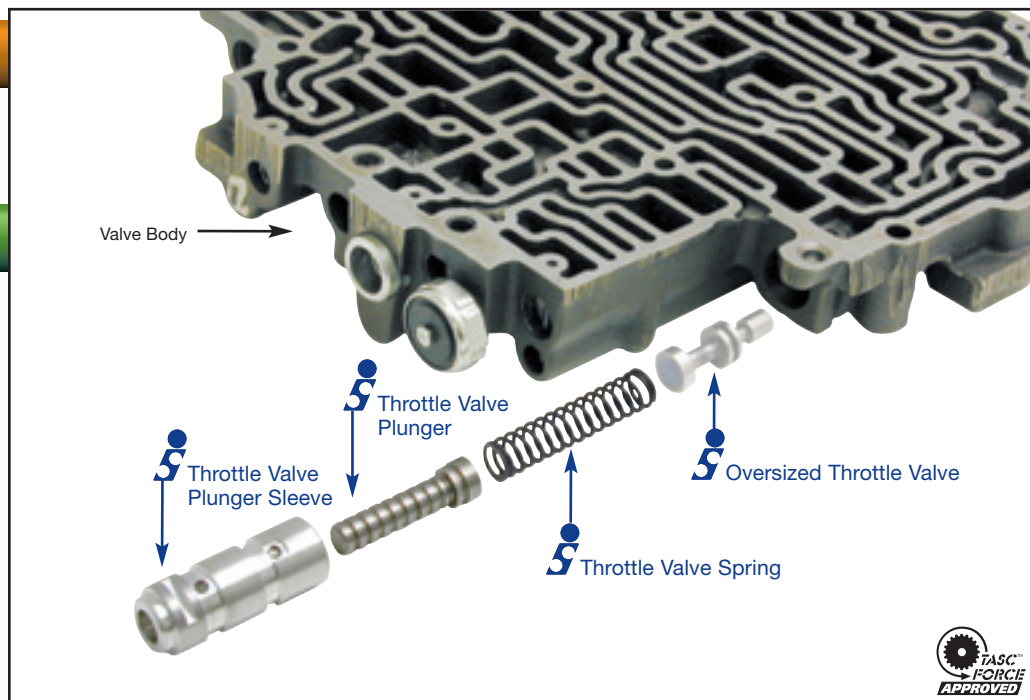
The steel TV plunger wears the TV plunger sleeve, allowing TV feed oil to leak past the plunger and exhaust.

Poor line rise or no detent downshifts can be common complaints in vehicles with a THM 700-R4 transmission. The steel throttle valve plunger continuously reciprocates within the aluminum throttle valve plunger sleeve, wearing the sleeve. This wear allows throttle valve feed oil to leak past the plunger and exhaust, resulting in poor line rise and problematic downshifts. In addition, the OEM spring is weak and can result in low line rise, insufficient throttle pressure and, ultimately, 3-4 clutch failure.

These valve and sleeve kits restore the hydraulic integrity of the circuit.
