Oversized Throttle Valve

Sonnax Part Summary

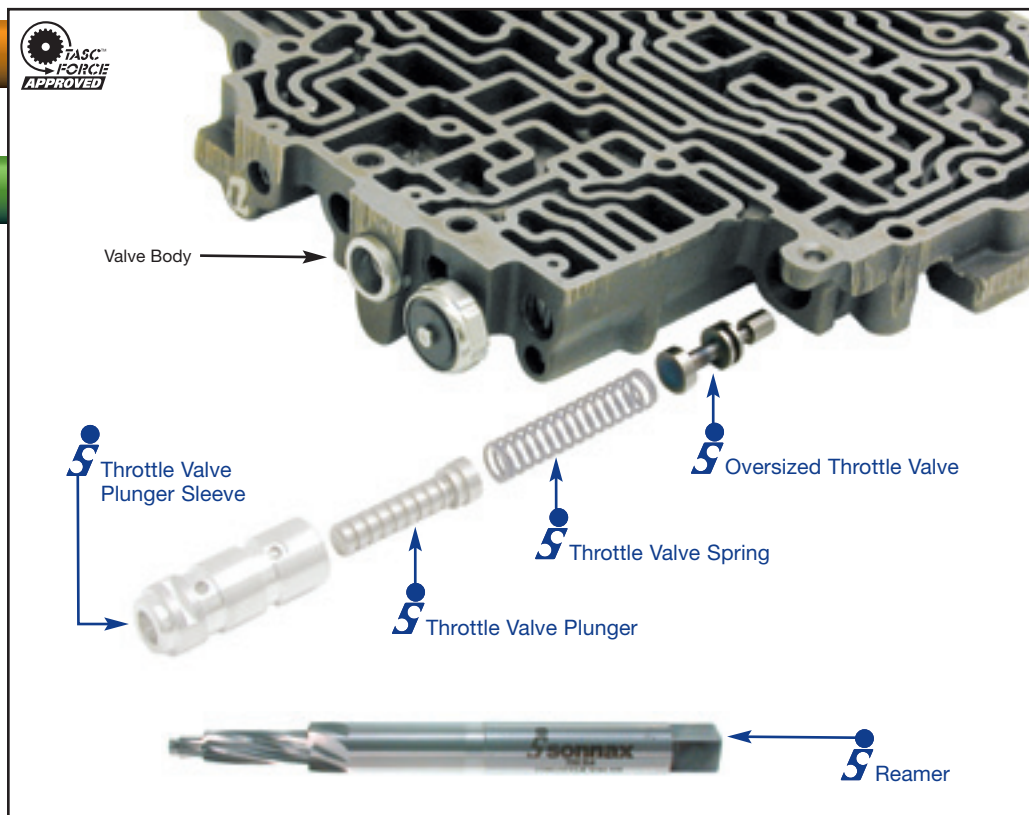
Poor line rise

- 3-4 clutch and band failure

A low throttle boost oil condition.

Stop excessive leakage by installing this oversized replacement throttle valve with slightly larger spool diameters.
