Oversized Accumulator Pin & Reamer

77999

Sonnax Part Summary

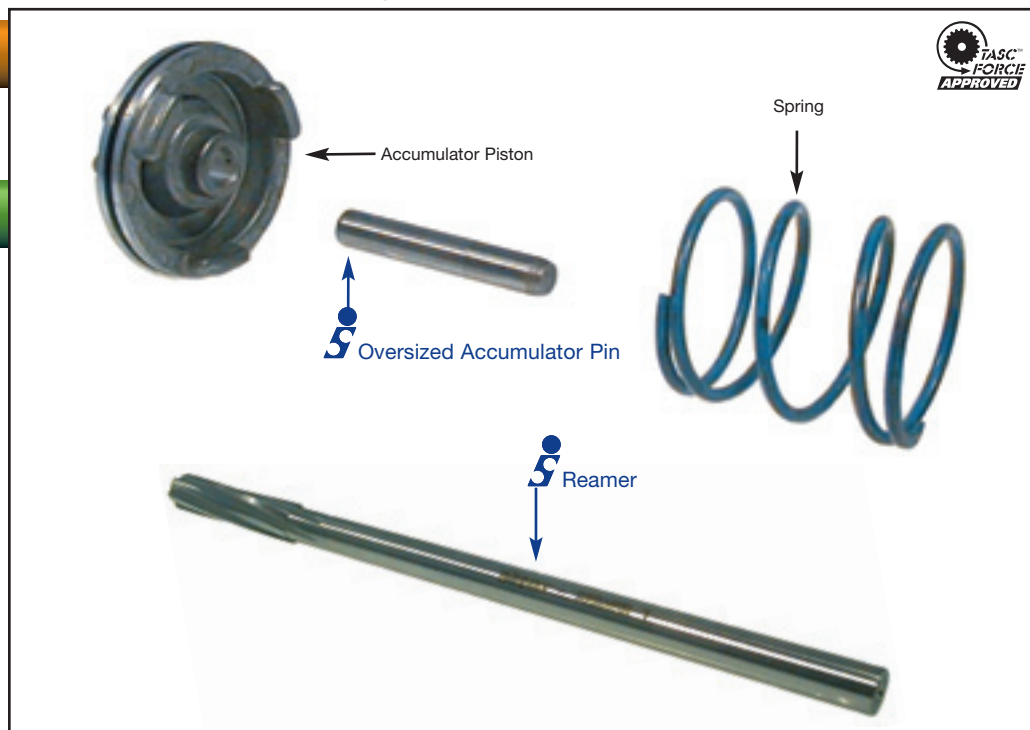
Wear at the accumulator piston pin bore allows oil cross leakage.

A burned band on the 4L60, 200-4R or 325-4L transmission can be created by accumulator cross leaks. A driveability complaint of 2nd gear starts or 2-3 bind-up can result from excessive piston wear. These complaints can be caused by oil cross leakage between the piston and pin in the 1-2 and 3-4 accumulators. This is due to the constant oscillating motion of the aluminum accumulator pistons on the steel pin. Band apply pressure is simultaneously sent to the accumulators and band. The problem occurs when accumulator control oil and band apply circuits cross leak. Accumulator control oil will bleed into 2nd apply or 4th apply and drag the band/clutch due to imbalanced oil circuits. Install the Sonnax replacement accumulator pin **77999** to resolve these problems.

Install this oversized accumulator pin after the bore of the accumulator piston is modified to restore proper clearance and circuit integrity.
